AIRCRAFT ACCIDENT REPORT

TRANS WORLD AIRLINES, INC.,
BOEING 727-31, N840TW
NEAR SAGINAW, MICHIGAN
APRIL 4, 1979

NTSB-AAR-81-8

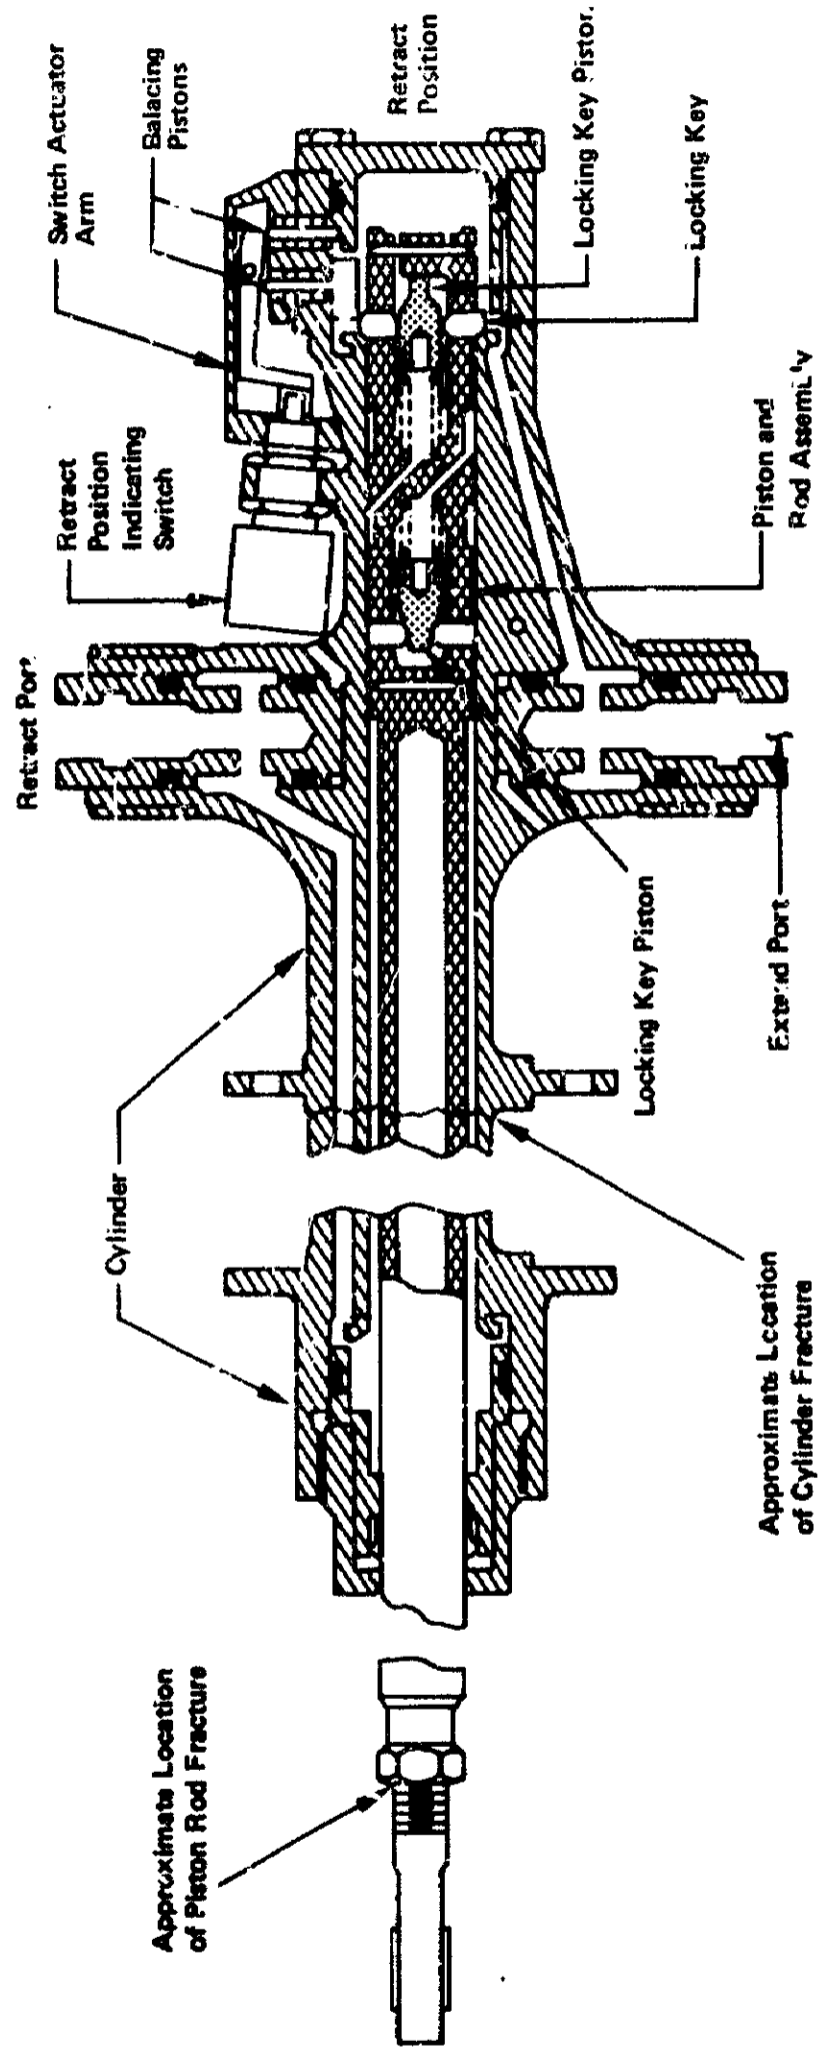
Figure 3.--Leading edge slat actuator.

All leading edge slats are held in the extended and retracted positions by hydraulic pressure and by mechanical locking devices in each actuator. (See figure 3.) The locking devices are held in the locked position by springs and hydraulic pressure and are unlocked by hydraulic pressure. A switch on each actuator is connected to the cockpit light display. One display, on the pilots' instrument panel, provides an amber (in transit) light when an actuator is unlocked, a green light when all actuators are extended and locked, or no light when the actuators are retracted and locked. The other display, aft of the flight engineer's panel, provides a display of the condition of each individual leading edge device. When activated, this display will show whether an individual leading edge device is extended and locked (green light), retracted and locked (no light), or unlocked (amber light).

The forward two-thirds of the actuator cylinder, the actuator piston, the piston rod, the locking pistons, and the locking pins were missing; therefore, the condition of the piston, its seals, and the piston rod could not be verified. However, as described above, it is not likely that even a massive failure of either or both piston seals would have nullified the mechanical lock.

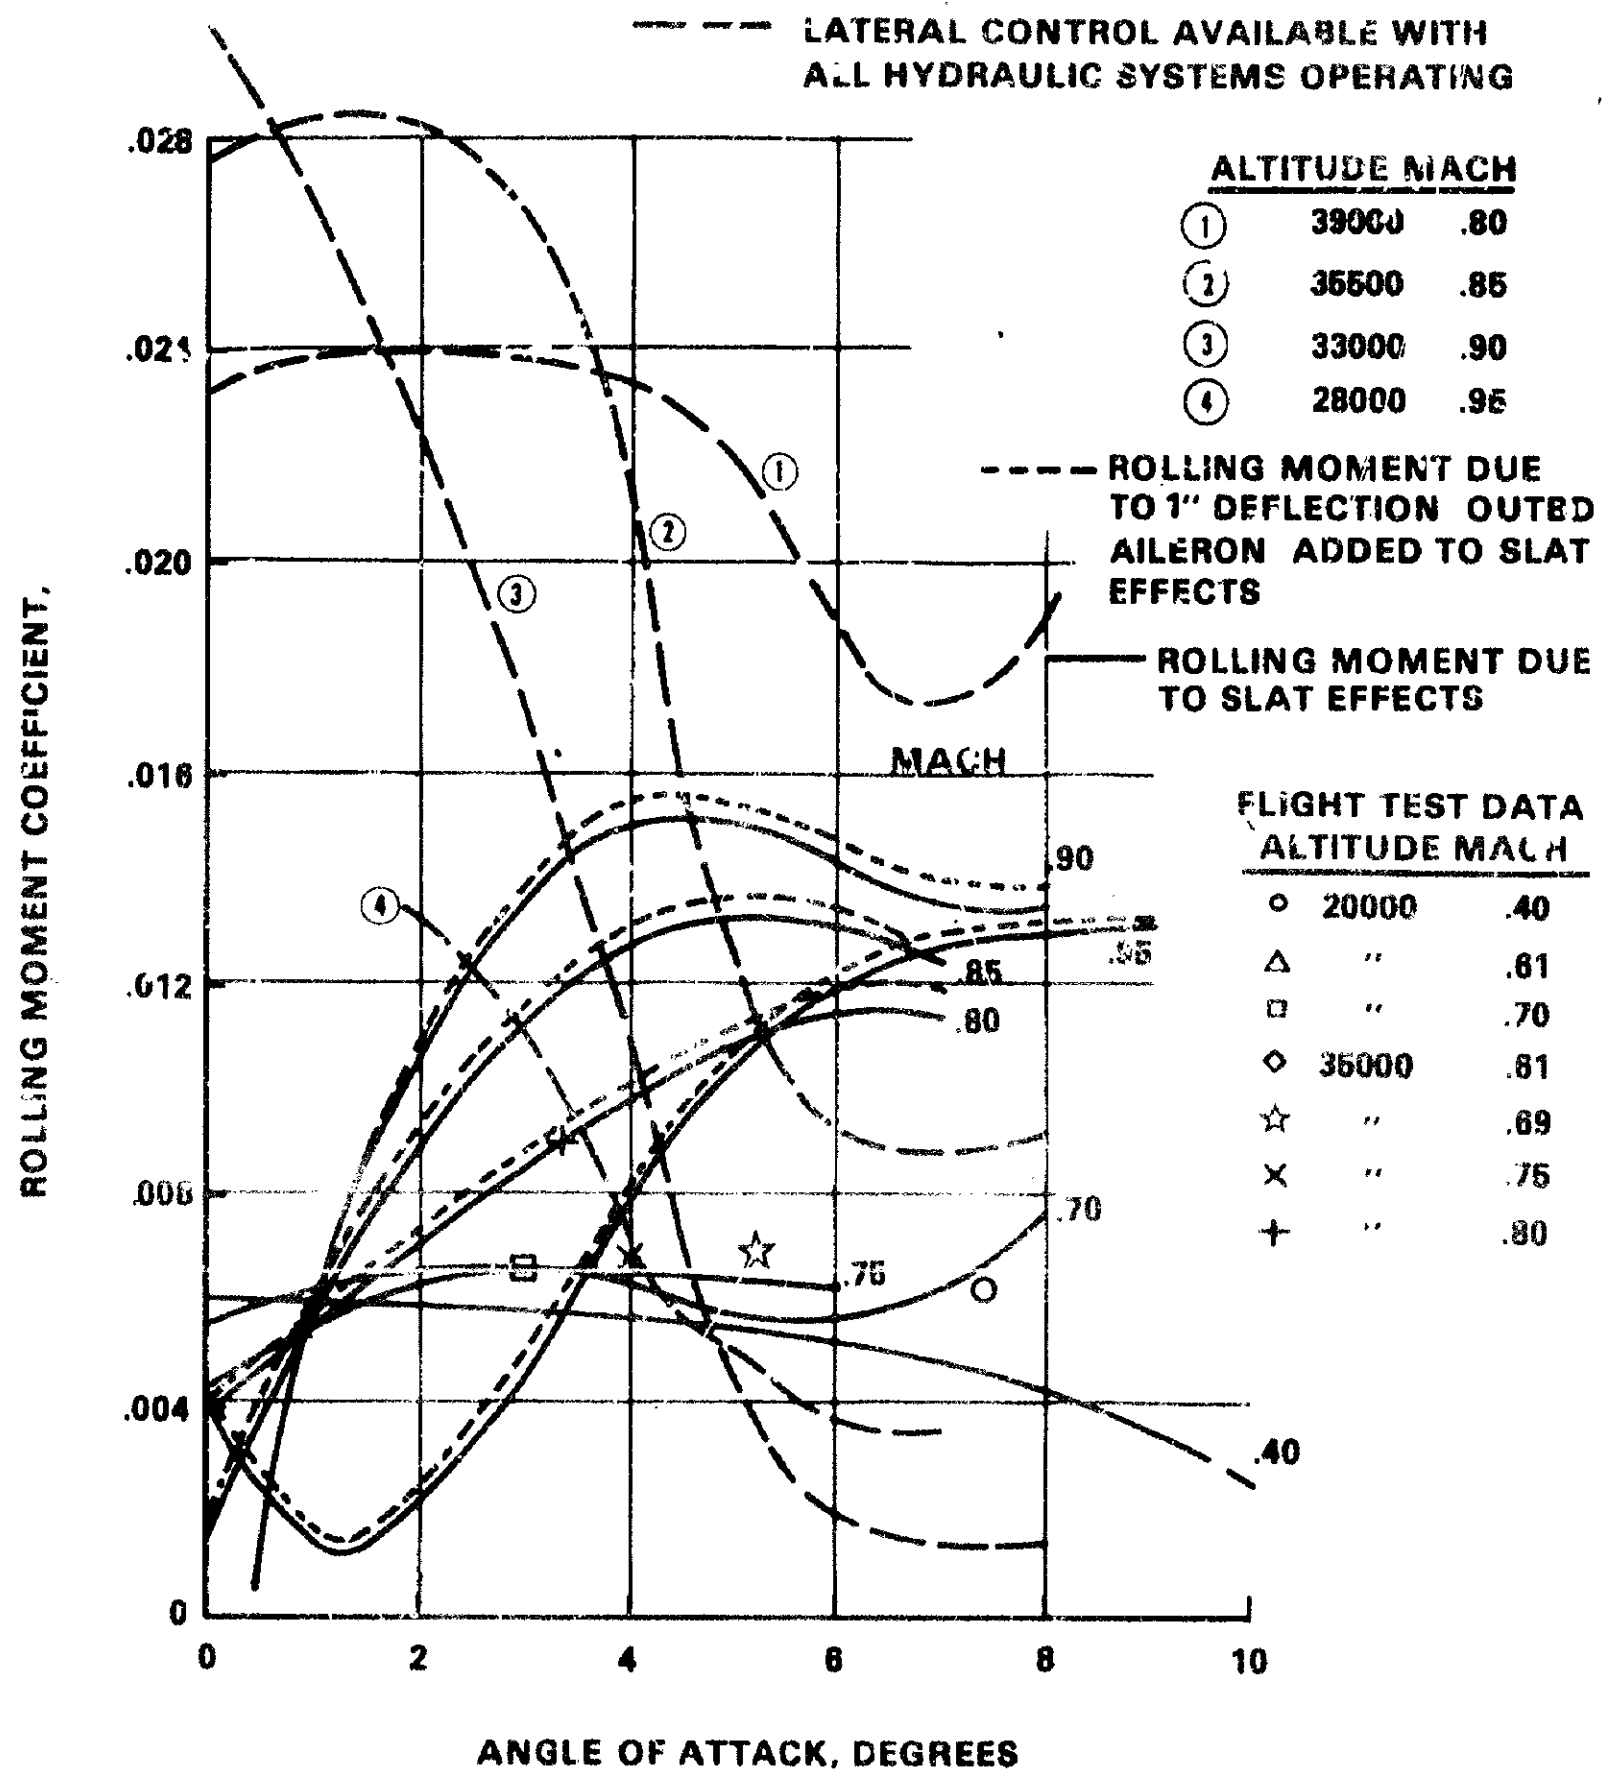
Figure 4.—Rolling moments from extended No. 7 leading edge slat -- adjusted to flight test data points.

The rolling moment coefficients caused by the extension of the No. 7 leading edge slat were supplied by the aircraft manufacturer from wind tunnel and flight test data developed in 1975. These coefficients were compared to the lateral rolling moments available from aileron and spoiler controls at various mach numbers and altitudes as a function of wing angle of attack. The comparison showed that at Flight 841's cruise altitude of 39,000 feet and at a cruise angle of attack of 4° , the rolling moment available from lateral controls at mach 0.80 exceeded the rolling moment caused by the extended slat by a factor of about 2. At 37,000 feet, mach 0.85, and an angle of attack of 5° , the rolling moments were approximately equal. Further increases in the angle of attack or

Using the adjusted rolling moment data, a dynamic analysis of Flight 841's maneuver was performed. This analysis showed that 12.5 seconds after development of the roll to the right caused by the extended No. 7 slat, the simulated aircraft reached an attitude such that lateral control could not be maintained by full deflection of lateral and yaw controls.

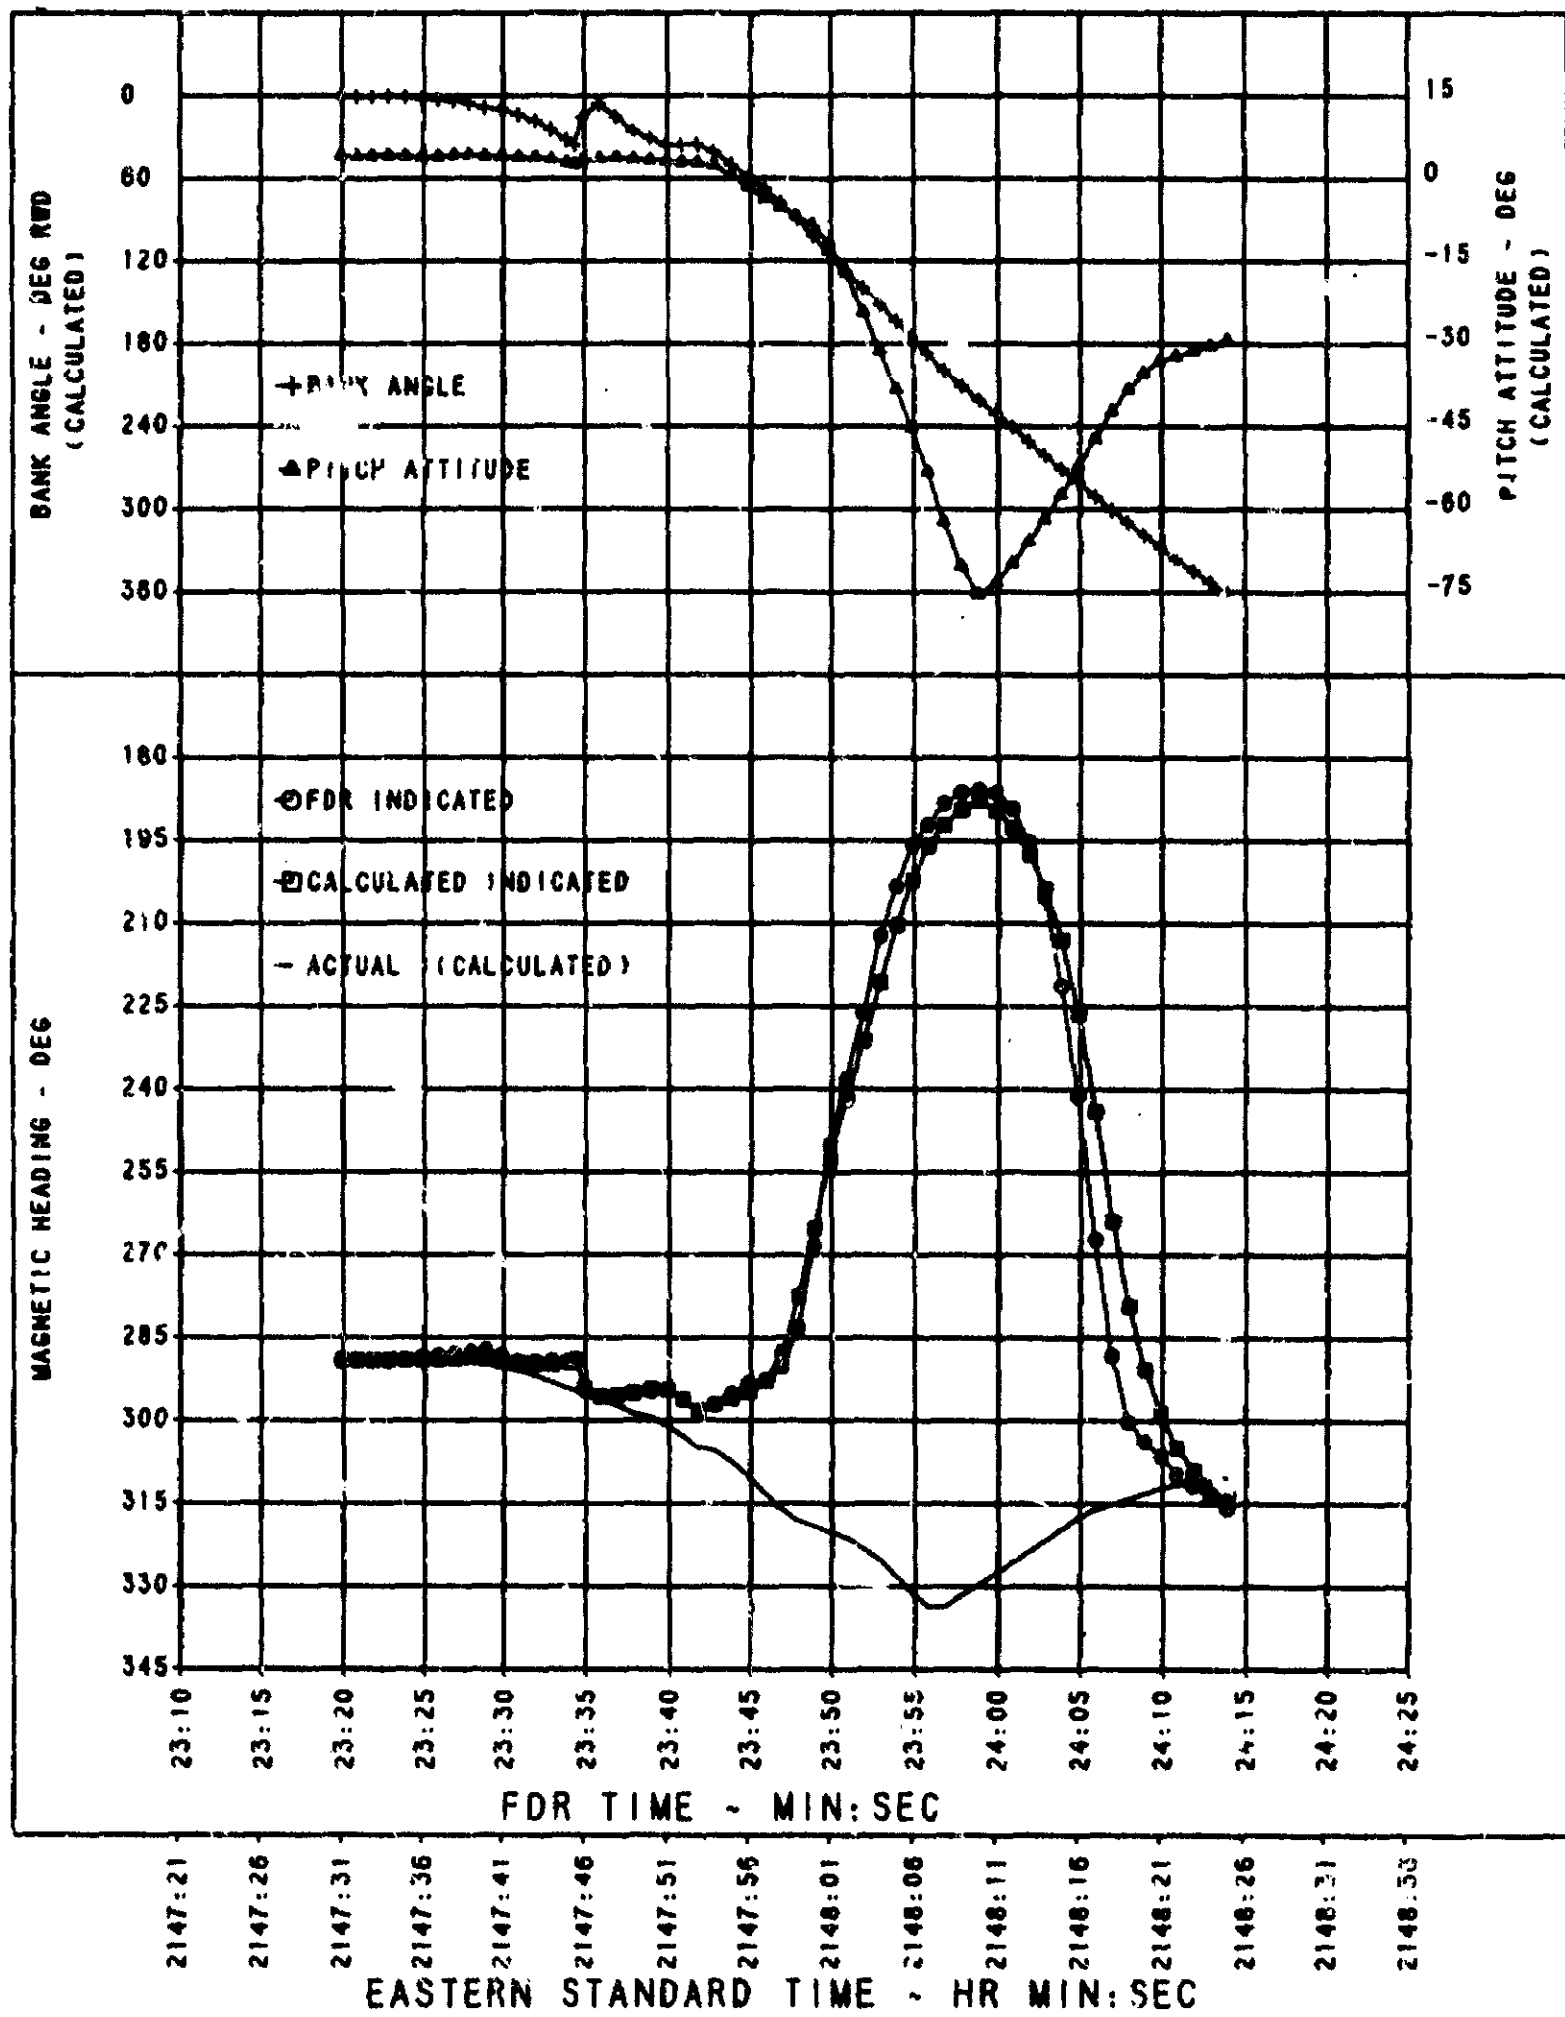
Figure 5.—Comparison of calculated and FDR headings.

As shown in figure 5, the calculated indicated heading trace for these heading, pitch, and bank angles compares almost exactly with the accident aircraft's FDR heading trace with the time shift removed. Beginning about 2147:34, the aircraft began to roll slowly to the right, and about 6 seconds later, the rate of roll began to increase. At 2147:45, the aircraft was in a right bank of about 35° , after which it was rolled rapidly to the left to near a wings-level attitude. About 2147:47, the aircraft began to roll again to the right, and the roll was arrested briefly at 2147:51 near 35° of right bank. At 2147:53, the aircraft resumed its roll to the right and about 2148:07, the aircraft was inverted with a pitch attitude about 45° below the horizontal. As shown in figure 5, the aircraft's actual heading (calculated) changed comparatively little during the 360° of roll.
