## AIRCRAFT ACCIDENT REPORT

In-flight Breakup Over the Atlantic Ocean  
Trans World Airlines Flight 800  
Boeing 747-131, N93119  
Near East Moriches, New York  
July 17, 1996

**NTSB/AAR-00/03  
DCA96MA070  
PB2000-910403  
Notation 6788G  
Adopted August 23, 2000**

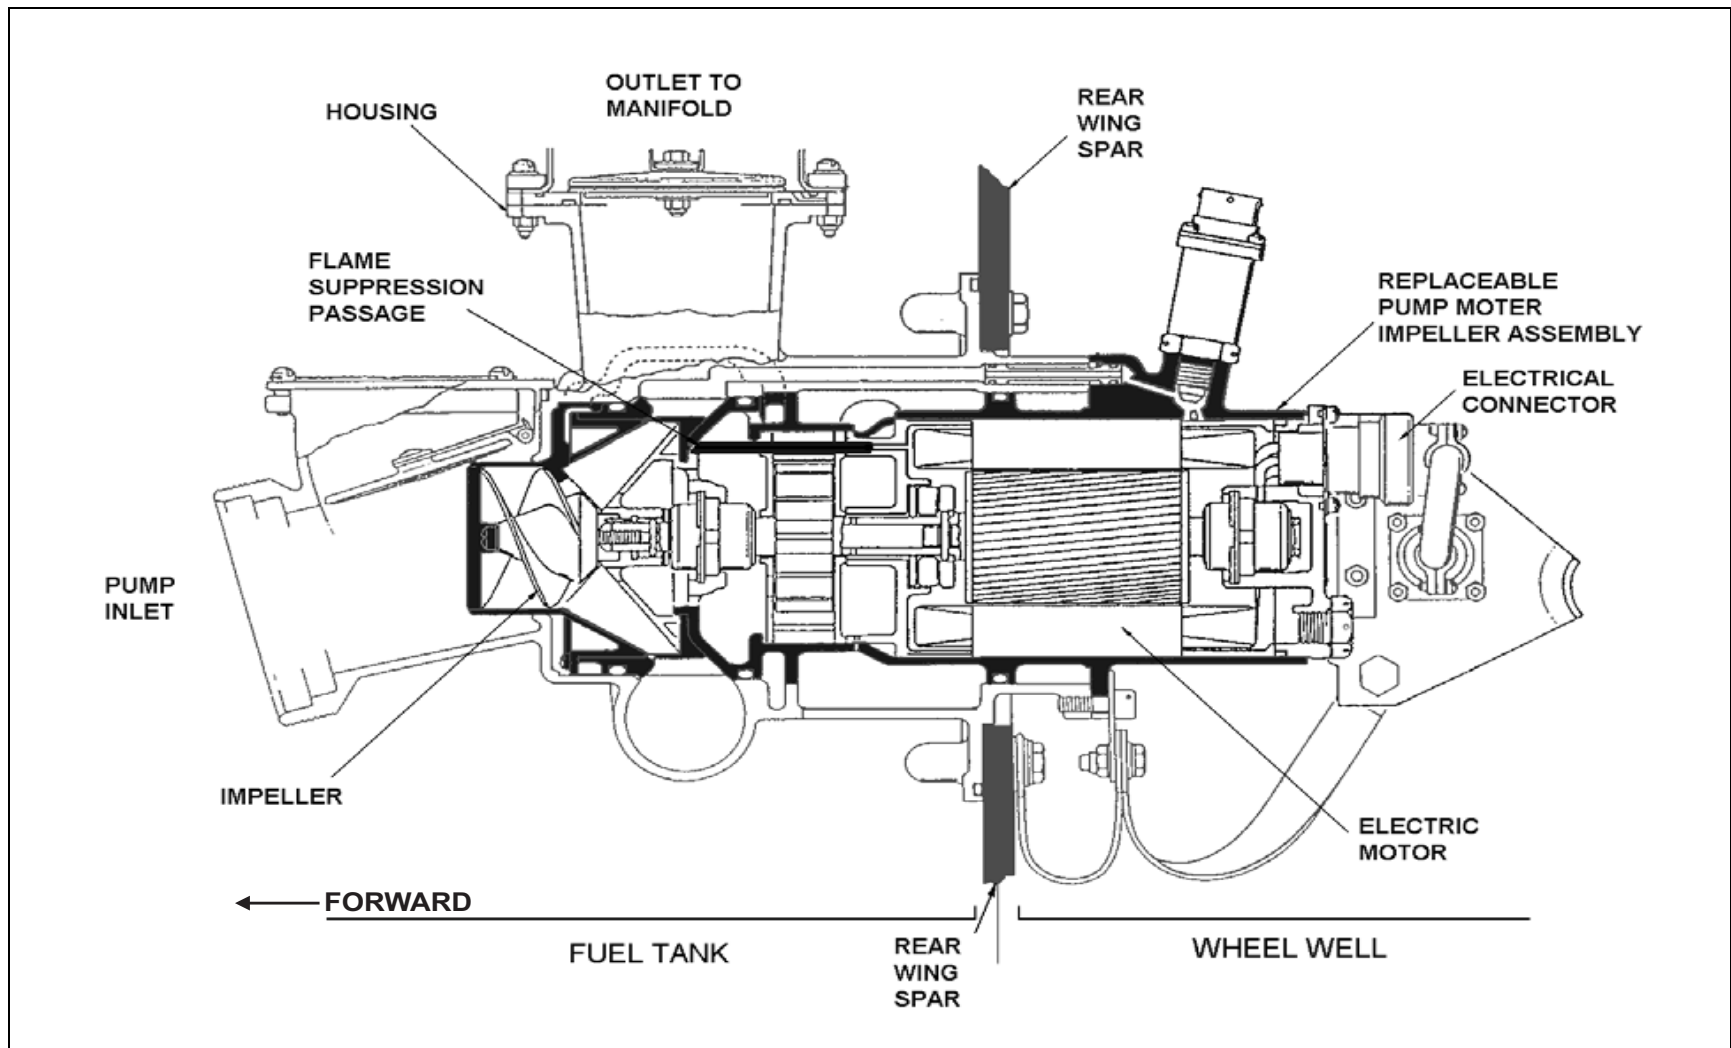
<sup>147</sup> Similar, but extensively deeper rubbing damage was found in jettison/override pumps in the Philippine Airlines 737 that had a CWT explosion on May 11, 1990. The Safety Board conducted tests for 2 weeks to determine whether galling between aluminum surfaces within the pump could have ignited flammable vapors. The investigative group was not able to ignite flammable vapors by impeller rubbing or by other types of contact between internal fuel pump components.

Figure 23. A diagram of a jettison/override fuel pump.

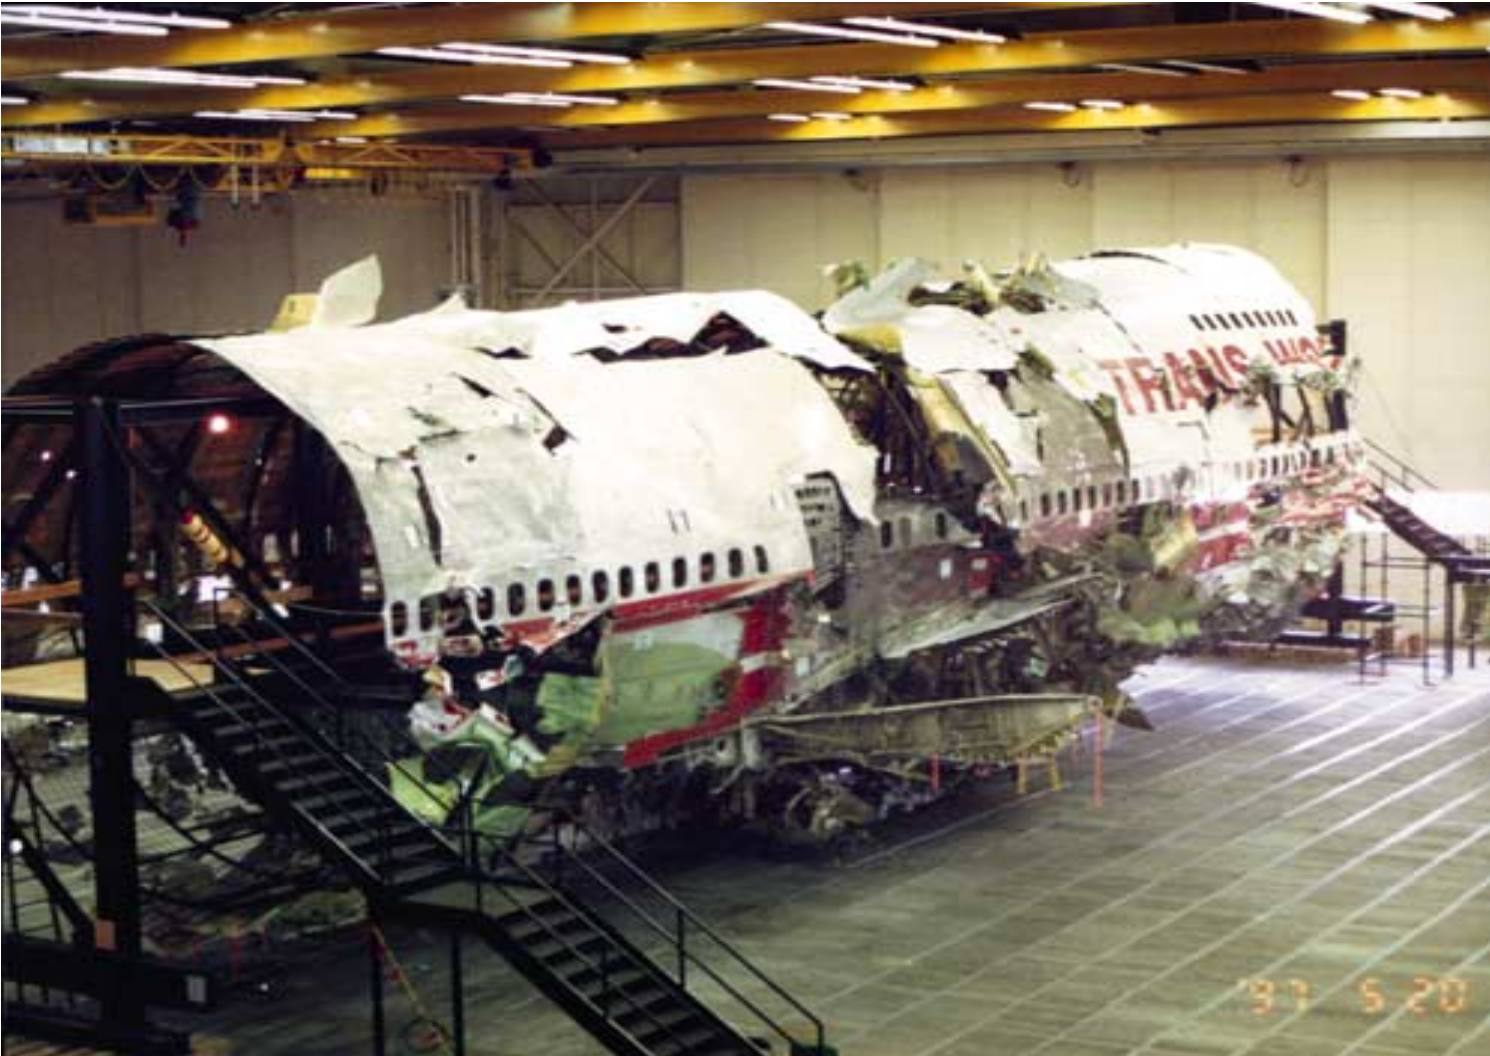
**Figure 29.** A photograph of the right side of the large three-dimensional reconstruction, with the support scaffolding visible.
