### CESSNA

#### Cessna: 172A; Failed Rod-End, Nose Gear Steering; ATA 3250

#### Cessna: 175B; Cracked Engine Mount Attach Brackets; ATA 5313

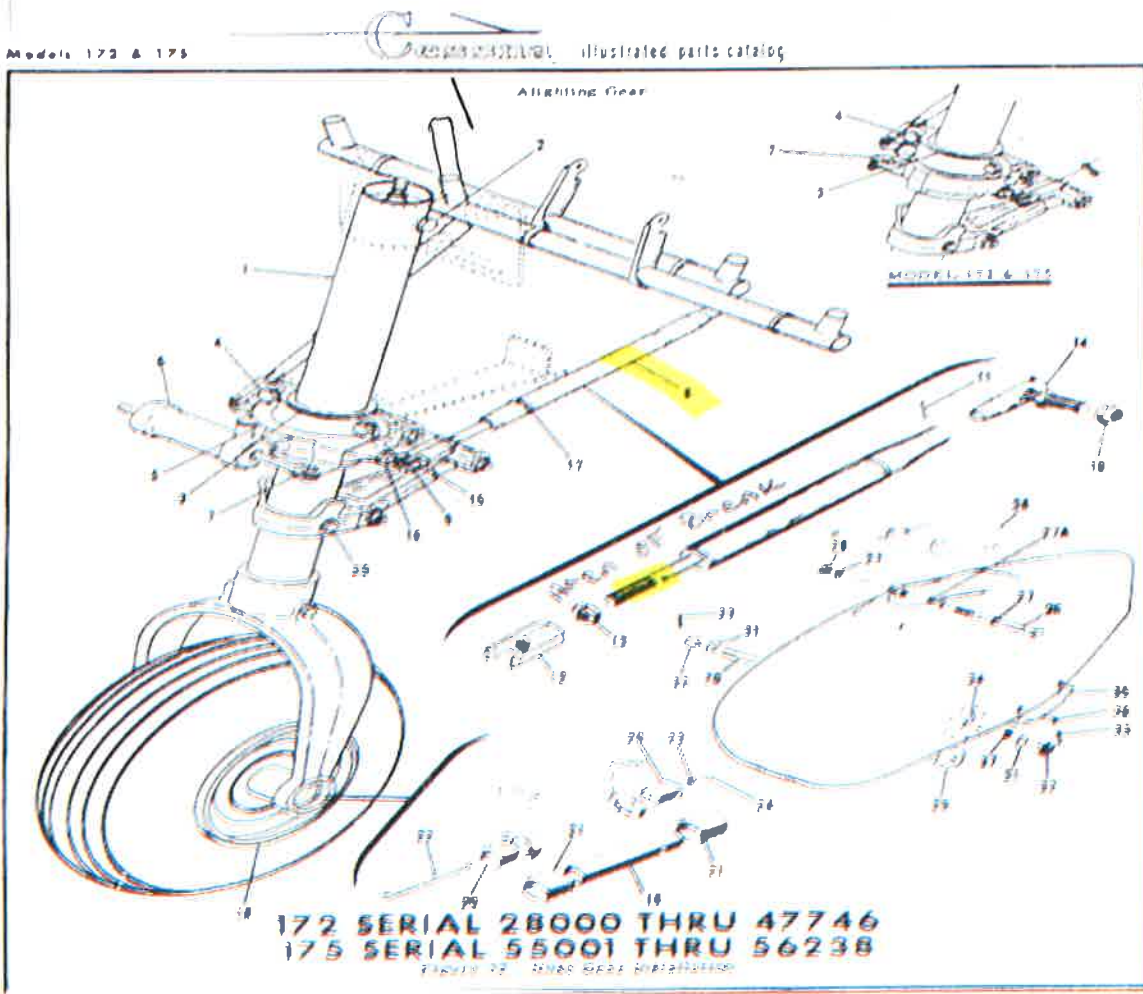
An FAA inspector from Spokane, Washington, submitted this defect report, indicating the cause of the 172's accident. The attached drawing shows the failure point on the nose gear steering tube's rod-end (P/N 0543022-1). "The aircraft turned left and impacted an embankment. A small amount of rust was *(noticed)* on the threaded area *(of the rod end)*." *(The attached drawing has been vertically compressed—fairly obvious!)*

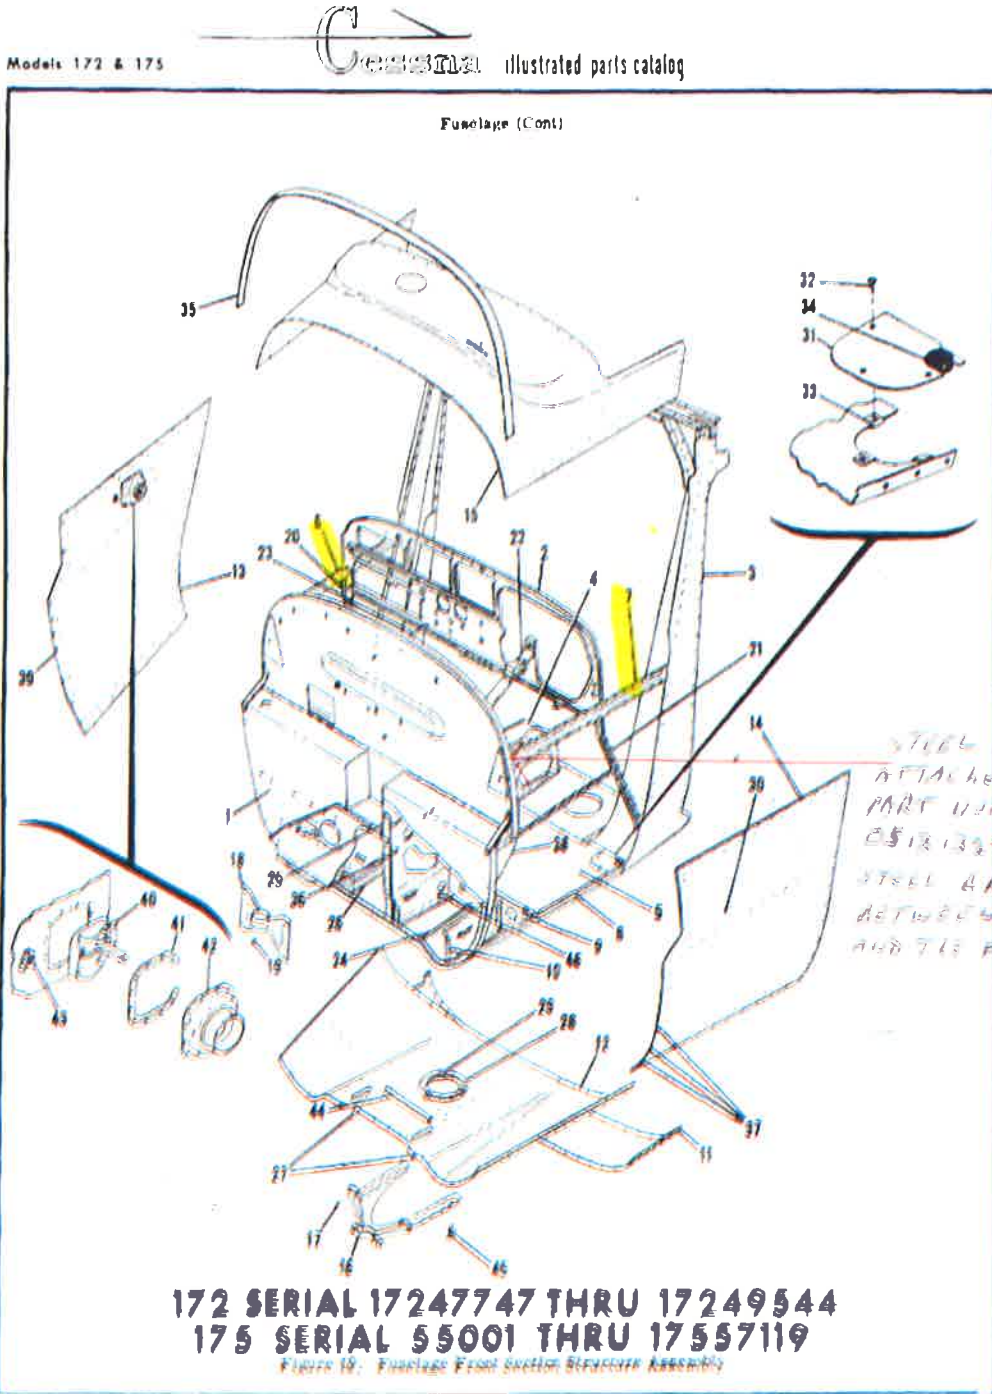
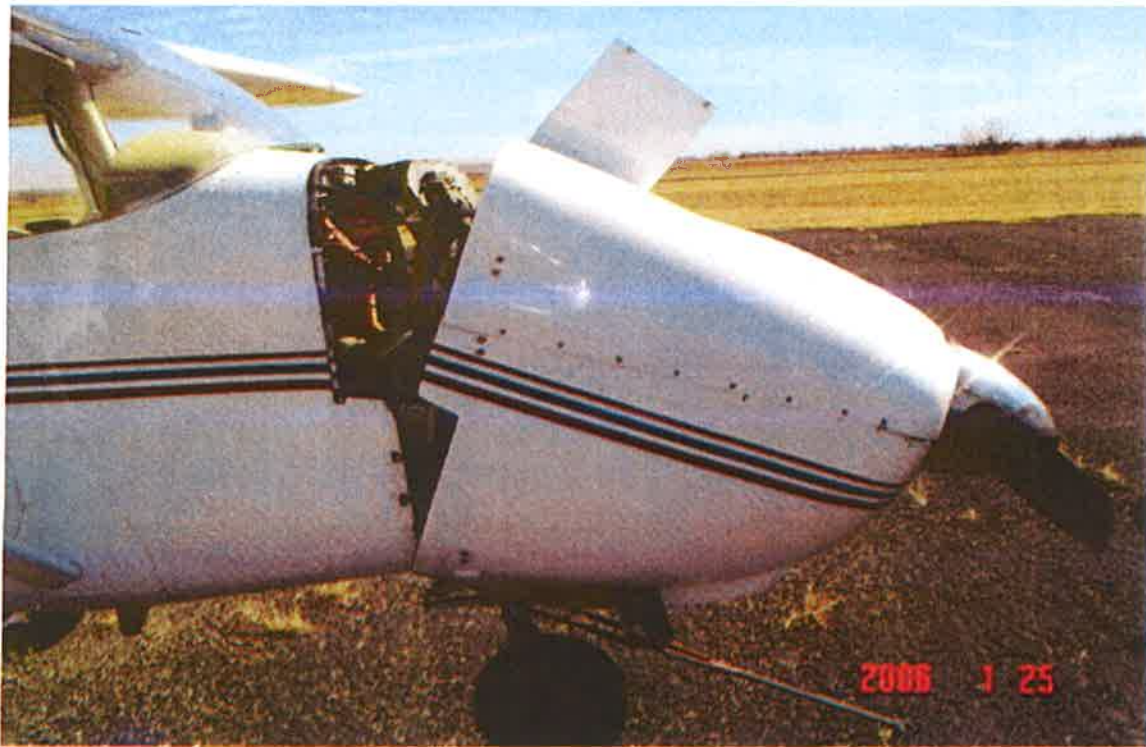
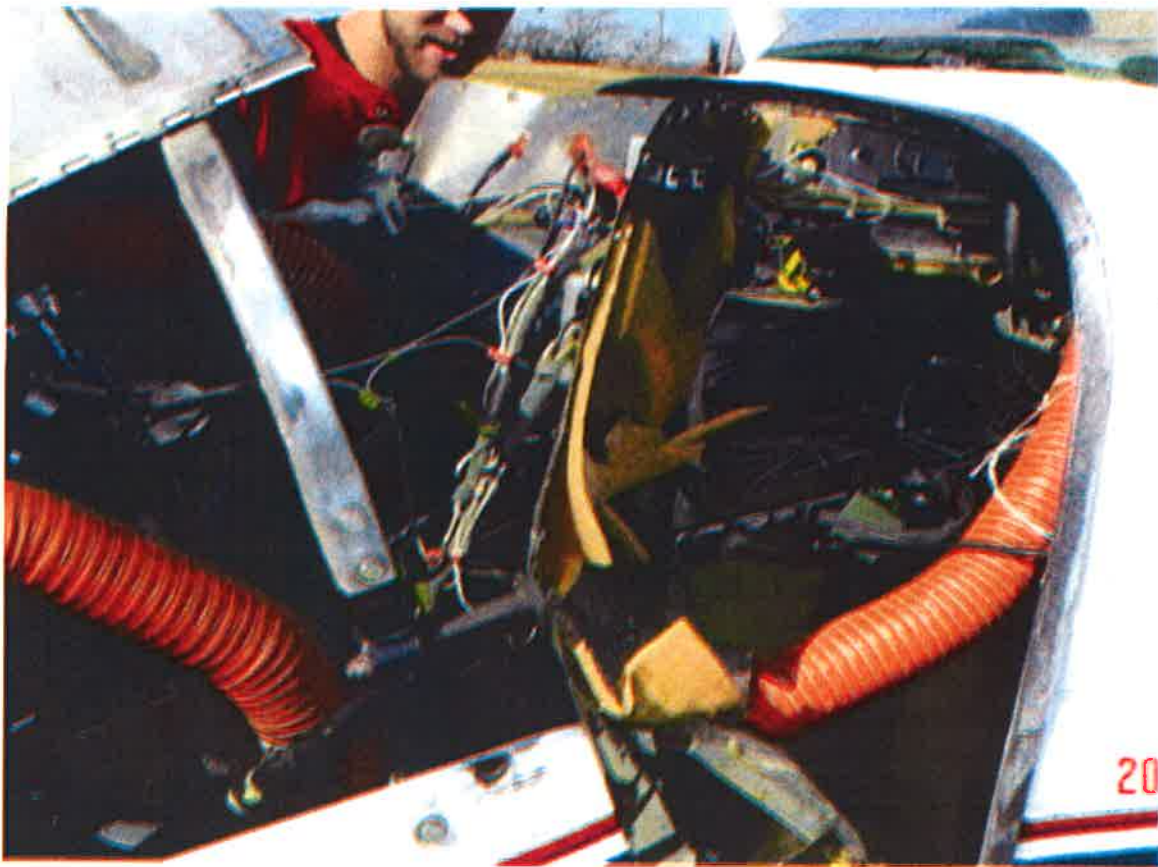
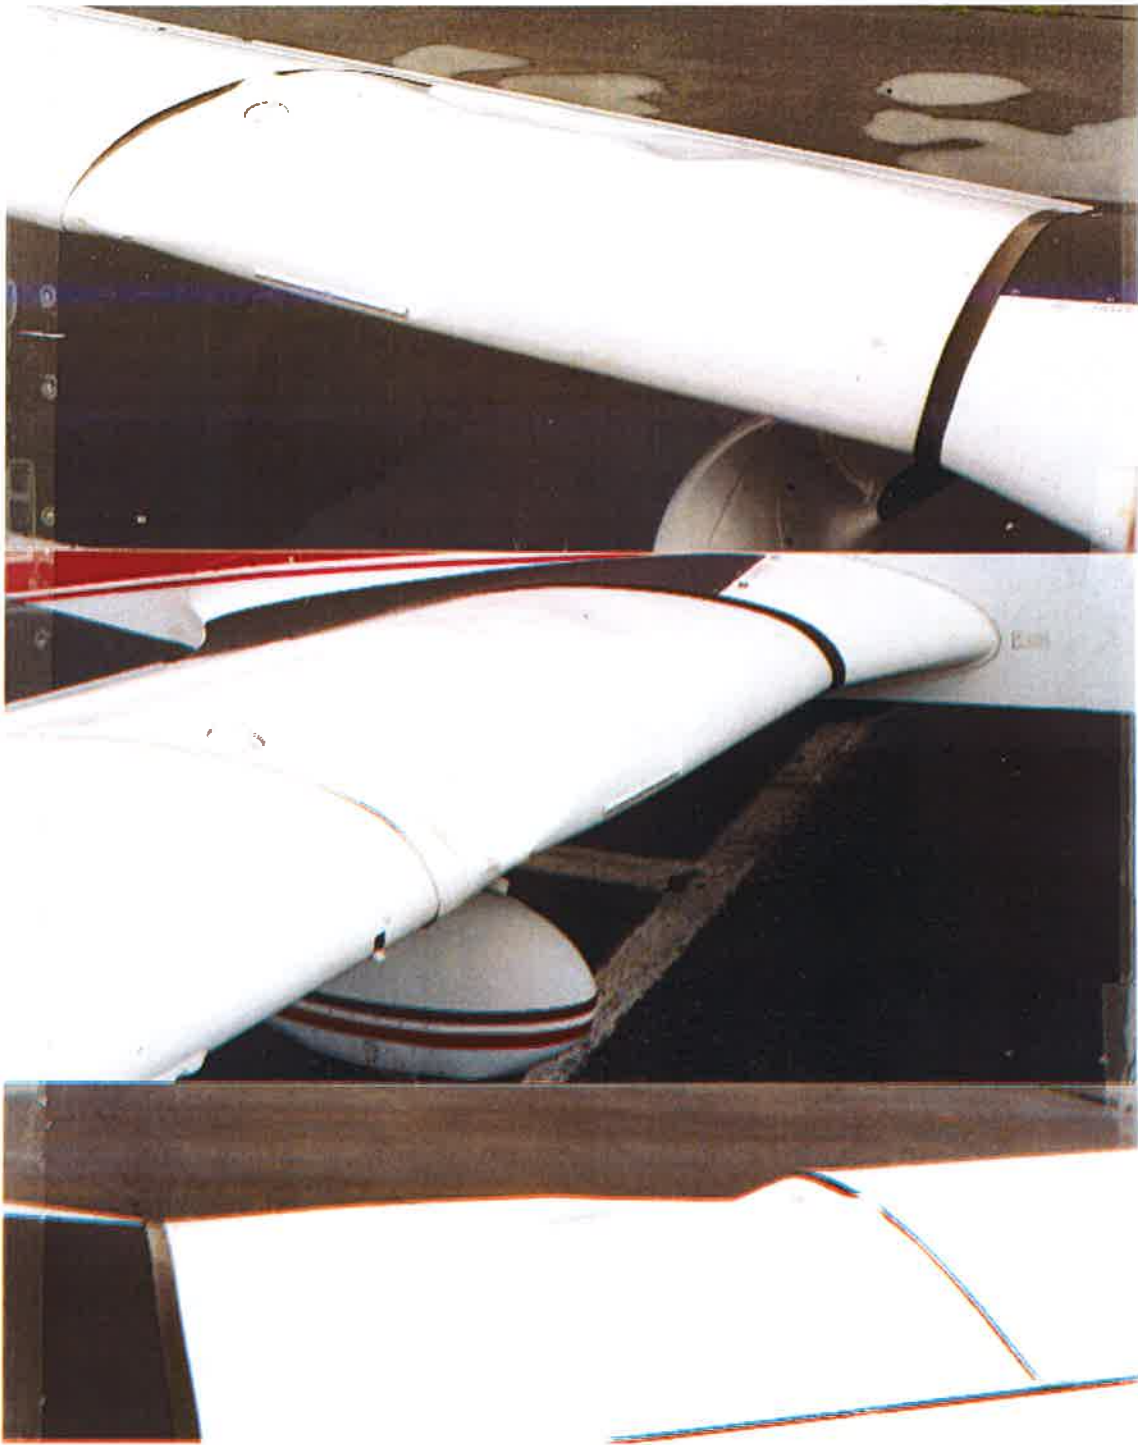
The submitter states, "This aircraft experienced a hard landing. During the landing the two top engine mount attach brackets failed behind the firewall, allowing the top half of the firewall to fail, pulling forward and down about 18 inches. (See the attached figure 19, items 7 and 6.) The part number 0513132-11 engine mount attach bracket fits onto the front of the hat channels (items 6 and 7). *(This same part)*--which has a hole in it for the

engine mount bolt to go through—had failed some time ago on the pilot’s top side..(as evidenced by rust being found in the break surfaces of two pieces). The bracket on the co-pilot’s top side had an existing crack in the center third—at the bolt hole. Rust was also (evident on these crack surfaces).” “This aircraft had an STC’d (Supplemental Type Certificate) Continental IO-360 engine installed....” (SDRS data base records 17 entries on this particular part number.)
