**Investigation of the  
Helios Prototype Aircraft Mishap**

**Volume I  
Mishap Report**

**January 2004**

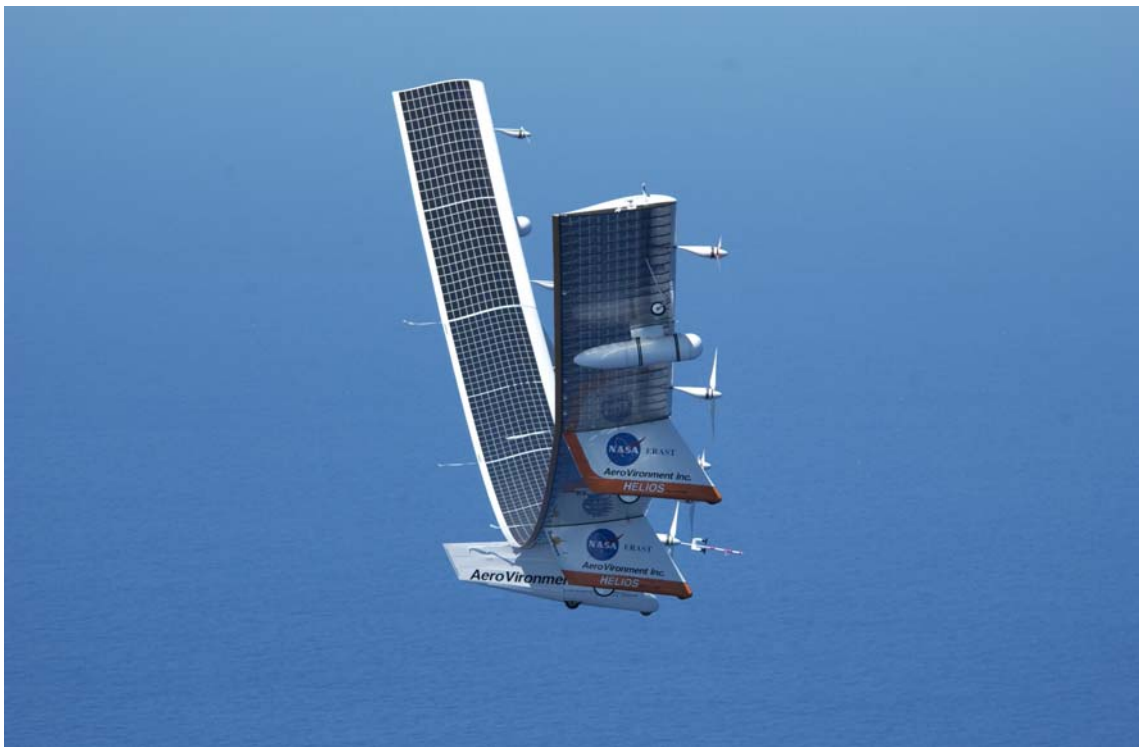
**Figure 7.4 - HP03-2 at High Wing Dihedral**

The SP had selected the wing-tip video camera to observe the aircraft because he believed it would give the best indication of wing dihedral and also how the aircraft was responding to any turbulence. At 10:35am, at approximately 2,800 feet altitude as defined by the Global Positioning System (GPS), the aircraft began experiencing airspeed excursions of around  $\pm 2$  ft/sec. At this time the wing-tip video indicated that the dihedral seemed high for the speed the aircraft was flying. When looking at the video, the camera view essentially pointed at the top of the center of the aircraft rather than the more usual view looking across the wingspan. The high dihedral persisted (Figure 7.4), and a pitch oscillation built up, similar to what had previously occurred but not observed and thus had not been interpreted as a potentially dangerous periodic oscillation. The SP noted that he was continuing to see large wing dihedrals and asked the Stability and Control Engineer (S&CE) to confirm that the correct procedure to reduce dihedral was to increase airspeed. The S&CE concurred, and at 10:35:12am the SP selected an increase in airspeed of 1ft/sec (37 ft/sec to 38 ft/sec). The dihedral decreased slightly then grew past 30 feet.

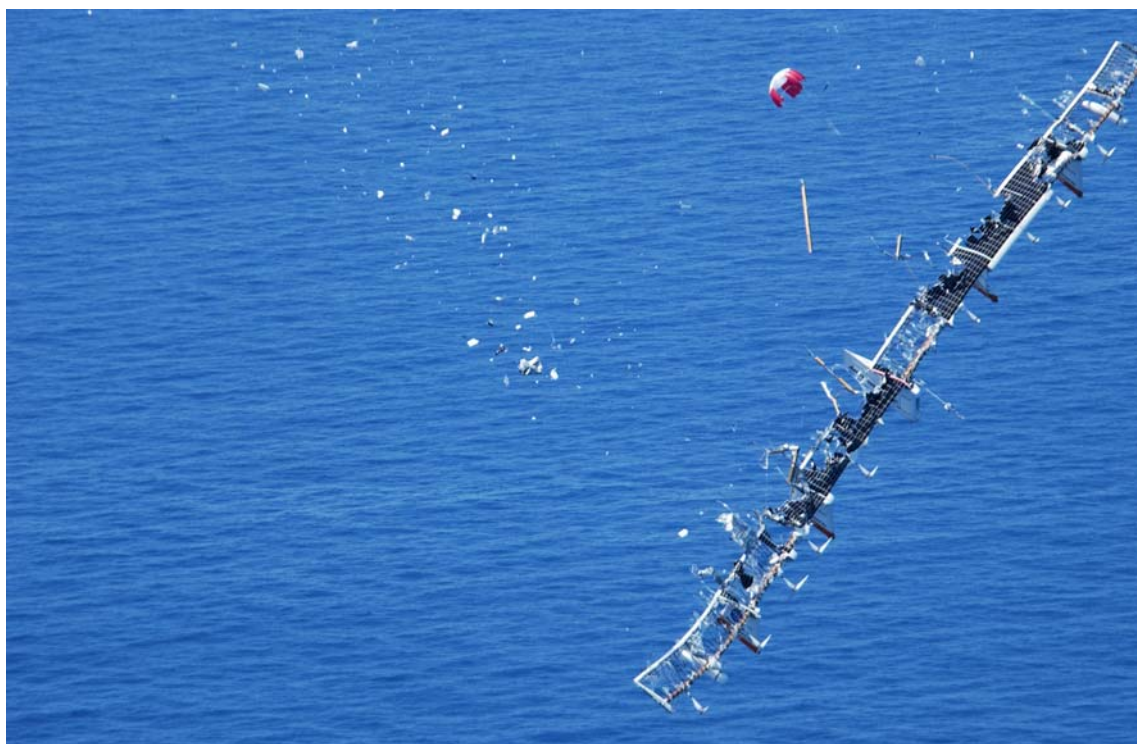
**Figure 7.5 – HP03-2 Falling Towards the Pacific Ocean**

At 10:36:28am at these extreme conditions, the aerodynamic loads broke the leading edge foam sections of the right wing near the hydrogen fuel tanks and then began ripping the solar cells and skin off the upper surface of the wing. The wing-tip video continued to function for a few more seconds and showed other portions of the aircraft starting to tear away as the aircraft continued to destruct. The last video frames show the wing sweeping aft. This could be due to the fuel cell weight at the aircraft centerline and increased drag outboard due to loss of the skin. Figure 7.5 shows a photograph of the aircraft as it is falling towards the ocean.

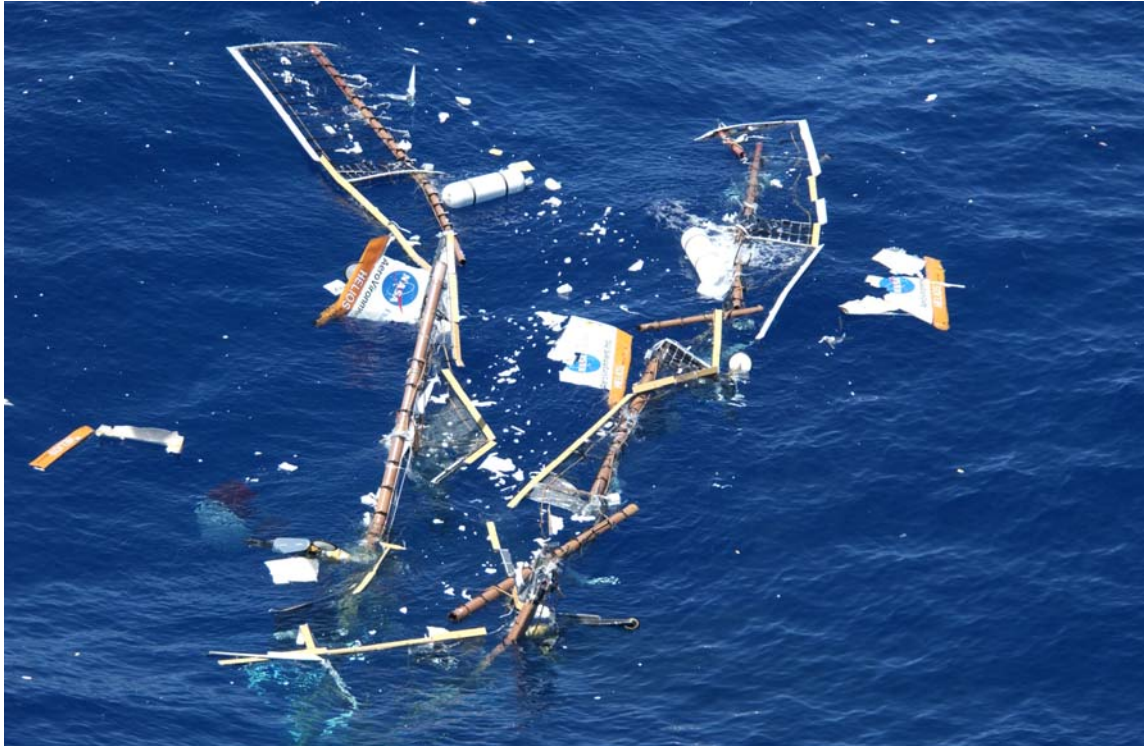
**Figure 7.6 – HP03-2 upon Impact with the Ocean**

At 10:37am, the aircraft impacted the ocean in mile-deep water 10 miles off the coast of Kauai, where, upon impact, the structure including the main load carrying composite wing spars were severely damaged (Figure 7.6). The elapsed time from the first effort to diagnose and correct the high wing dihedral condition to the point at which the airplane began to break up in the air was 91 seconds. Figure 7.7 provides time histories of the aircraft's pitch rate and airspeed, and the wing dihedral for the 30-minute flight.

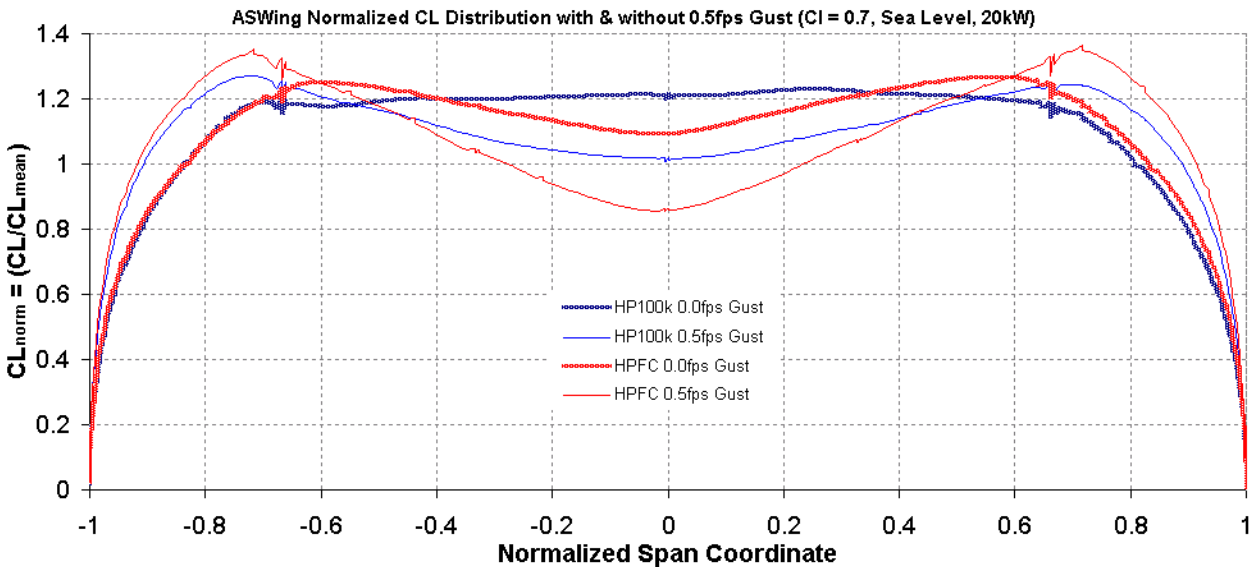
Figure 9.3 – Variation Spanwise Lift Distribution with Gust Velocity

Although general weather conditions seemed to be within the bounds present during previous PMRF flights, HP03-2's faster air speed and unchanged climb rate led to a different flight profile with greater exposure to the turbulence. As a result, HP03-2 flew a greater distance at low altitudes and thus was exposed to the turbulent patterns induced by Kauai for a longer period of time. Also, the HP03-2 encountered the shear lines at a lower altitude than previously, closer to the shear lines' regions of maximum turbulence.

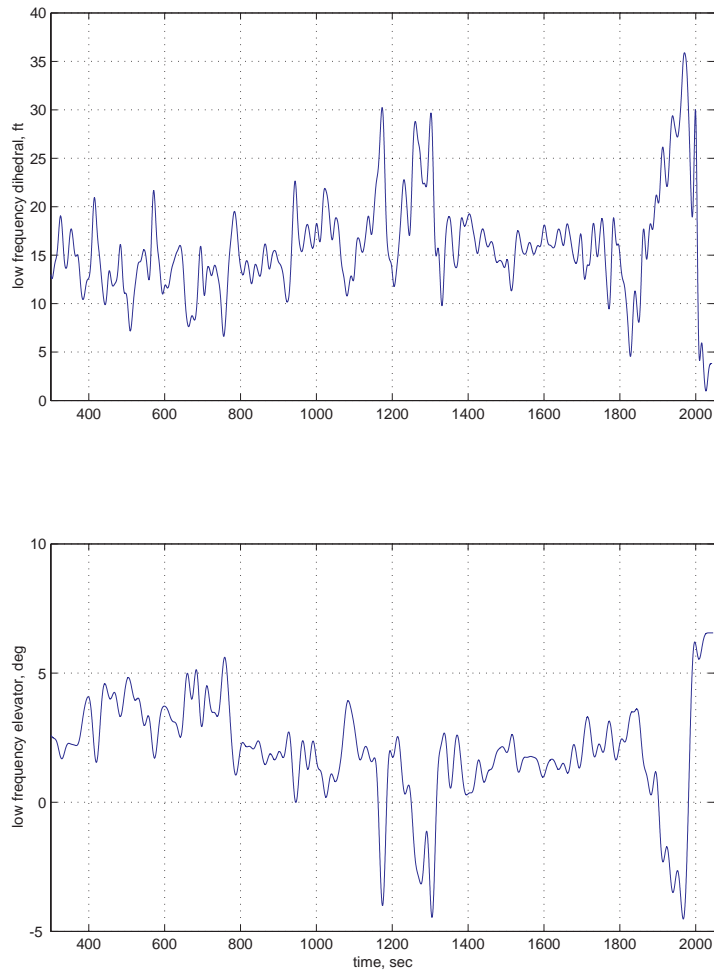
**Figure 9.4 – Time History of Wing Dihedral and Elevator Position**

Also through video interpretation, separated airflow on the center wing section did not contribute to the persistent high dihedral. The spanwise redistribution of lift from the center of the aircraft to the outboard panels caused by the loss of lift in the center panel is reinforced by the wing tips twisting leading edge up as dihedral increases. The primary cause of dihedral-induced twisting of the wing tip leading edges is the relatively forward center of gravity and the elastic axis of the wing being above the chord line of the wing. This interrelationship forces the wing to twist leading edge up as the tips bend up. Figure 9.4 provides time histories of the wing dihedral and the elevator position.

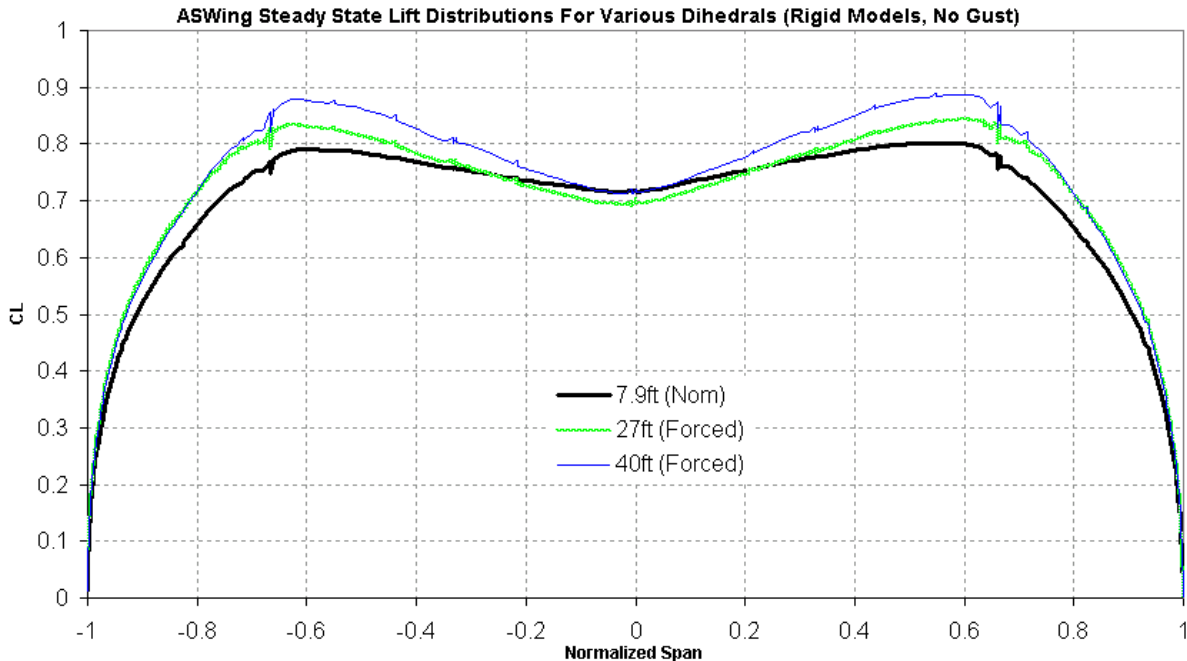
**Figure 9.5 – Spanwise Lift Distribution for Various Wing Dihedral**

The quantification of the primary effects of dihedral on elevator position and twist is best illustrated by analyzing the spanwise lift distribution. For a given airspeed and motor power setting, the predicted spanwise distribution of lift is provided in Figure 9.5. The spanwise redistribution of lift from the center of the aircraft to more outboard panels is the primary cause of the unexpectedly slow return to lower dihedral after any perturbation.

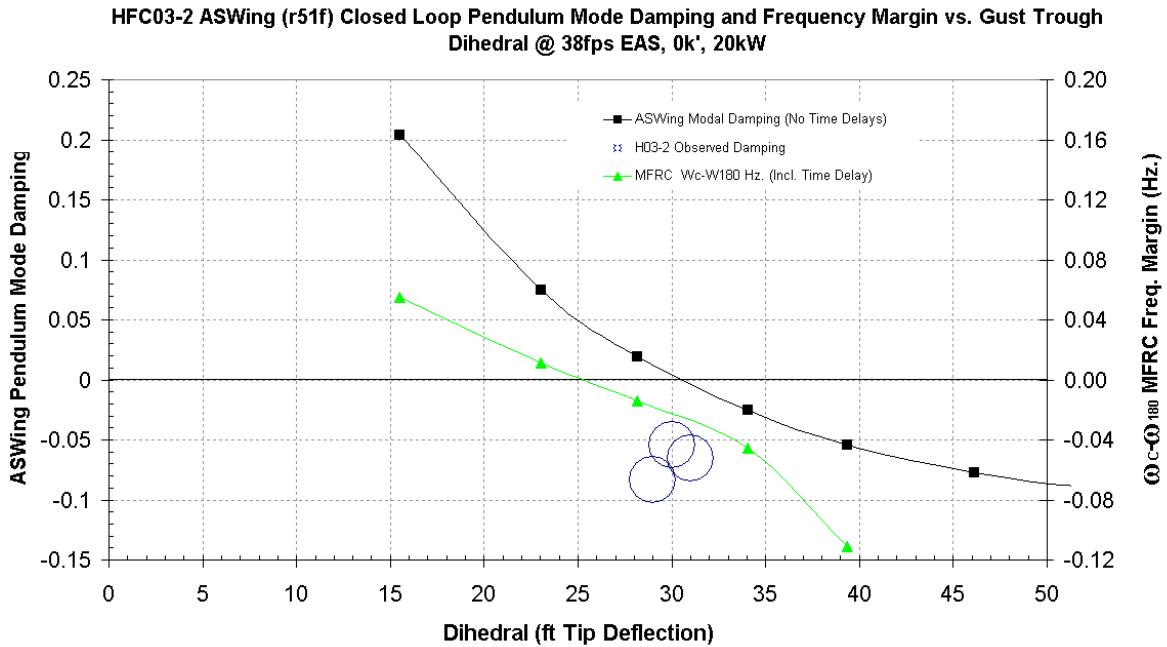
**Figure 9.6 - ASWing Predicted Phugoid Mode Damping for Steady State Flight at 38 ft/sec**

It is concluded that the persistent high dihedral caused the pitch instability. The pitch oscillation shares many characteristics with a traditional neutrally damped phugoid response of conventional fixed wing aircraft. For the Helios, the period of the neutrally damped pitch oscillation was about 8 to 9 seconds and the pitch rate was about 5 degrees/second. The stability of the oscillation was predicted and observed to be proportional to the wing dihedral of the aircraft. For wing dihedrals of about 30 feet wing tip deflection, the pitch oscillation became dynamically unstable. The predictions of the ASWing and Matlab codes, and flight estimates are shown in Figure 9.6.

The Matlab predictions, which included time delays determined during the flight test, agreed better with the flight observations. Although both models predicted more stability than observed in flight, they clearly capture the instability. The difference between predicted and observed neutral damping is not considered significant because the differences are about the same as the uncertainty of estimating wing tip deflection from strain gauge measurements. Clearly, the light to neutrally damped oscillations observed in an event 5 to 6 minutes before the crash corroborates these predictions. Figure 9.7 and Figure 9.8 graphically captures the damping estimates represented by two of the blue circles (first encounter or event involving the unstable mode and the mishap event) in Figure 9.6.

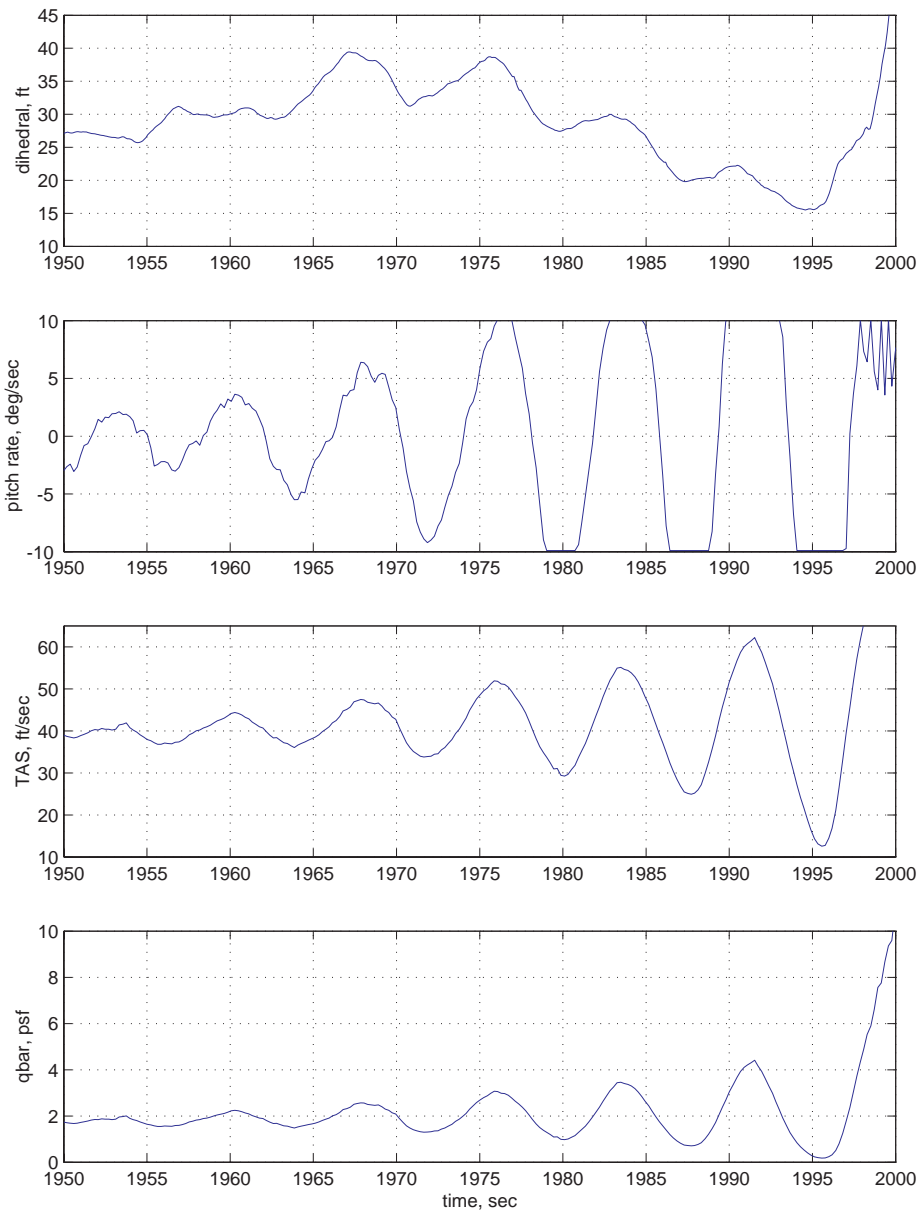
**Figure 9.8 - Dihedral, Pitch, Vehicle Airspeed, and Dynamic Pressure for Mishap Event**

At the large dihedrals, what may resemble a conventional neutrally damped, phugoid of a conventional aircraft is probably more accurately characterized as a dynamically unstable pendulum mode. The mode increases pitch attitude excursions, and increases airspeed with each nose down cycle despite apparent reductions in dihedral below the approximate 30-foot stability threshold. Those airspeed excursions quickly exceeded the maximum dynamic pressure design limit and resulted in the solar cell skin failures and subsequent loss of aircraft. The large wing tip deflections and more important, the persistence of dihedral was the physical cause of aircraft loss. Understanding the unanticipated large and persistent dihedral was a primary focus of post flight analytical analysis. The rapidly increasing airspeed excursions with each nose down pitch are obvious in Figure 9.8, the mishap event time history.

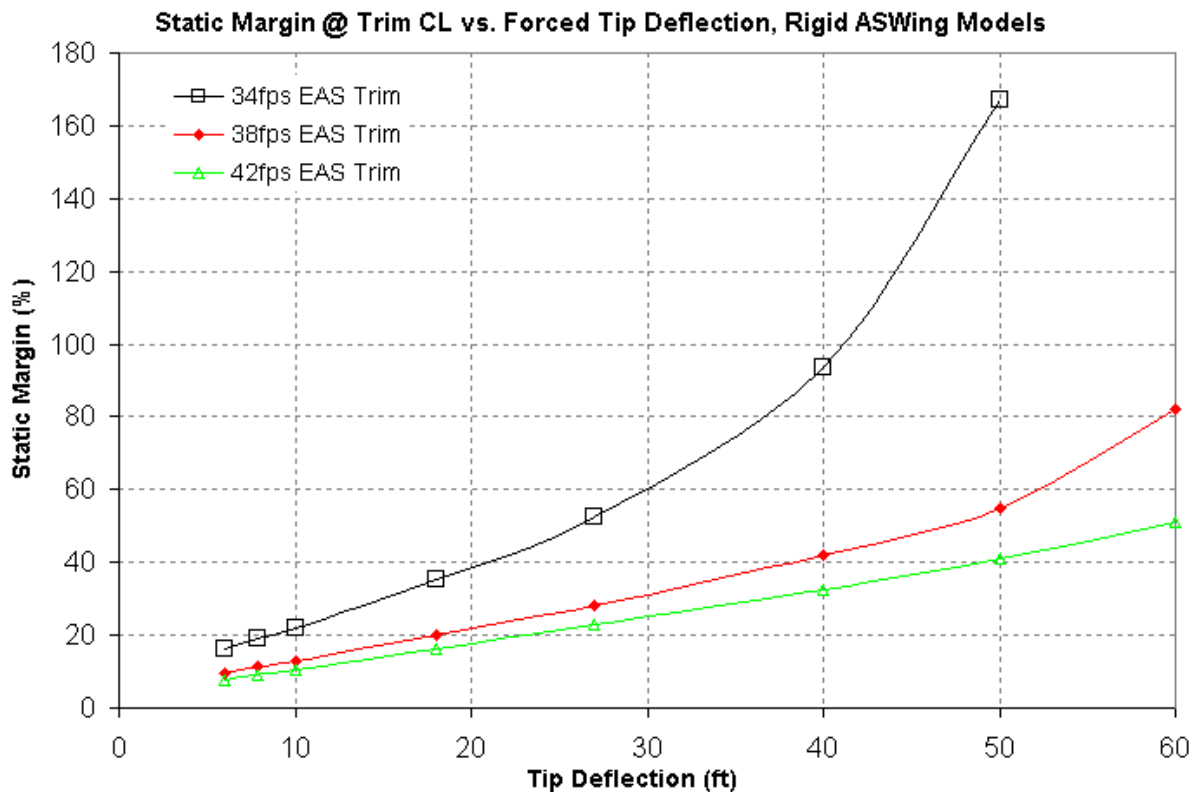
**Figure 9.9 – Static Margin Versus Aircraft Stability with Increasing Airspeed**

The underlying physics of the phugoid mode and its potential instability is thought to be a consequence of two primary factors. First, large longitudinal static stability that arises from a high aerodynamic pressure relative to center of mass as the wing tips bend up. As the dihedral increases, the center of aerodynamic force moves further above the center of gravity. The growth in static margin with increasing dihedral is shown in Figure 9.9. This increasing static stability is believed to increase phugoid instability.

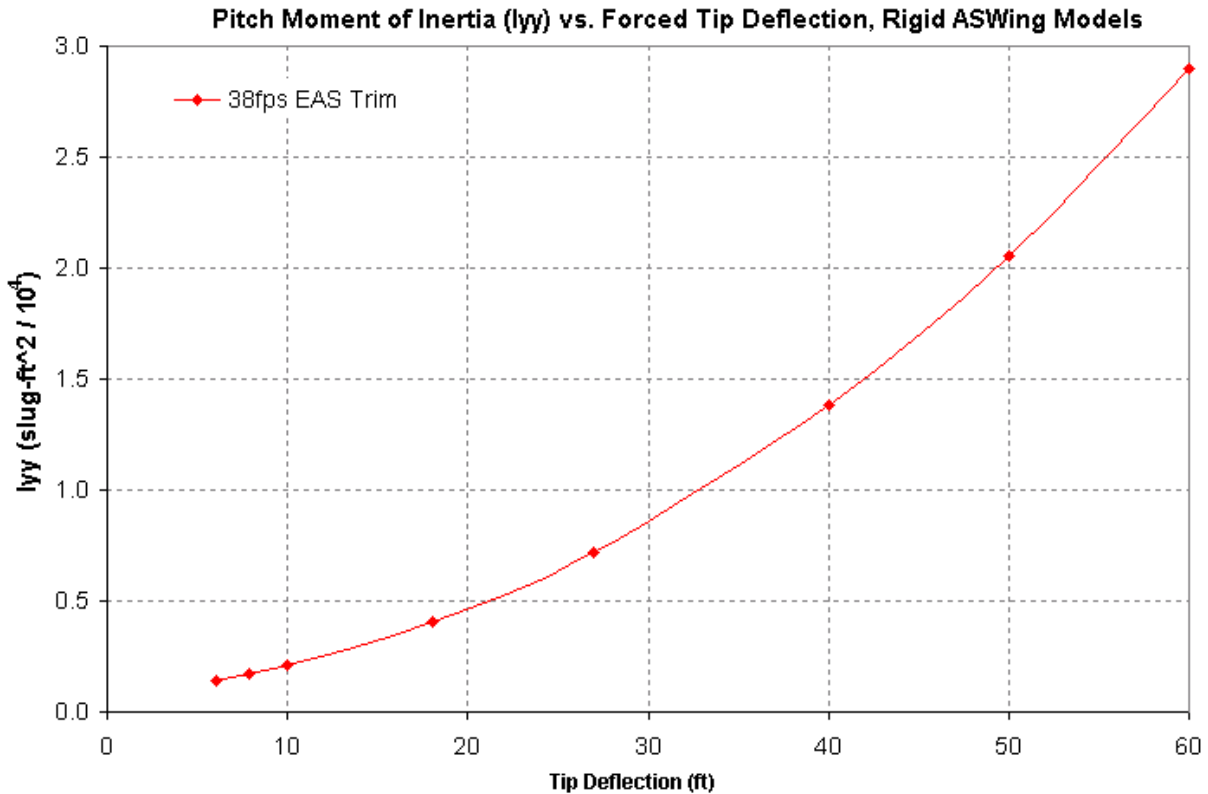
**Figure 9.10 - Aircraft Pitch Inertia Versus Wing Dihedral at 38 ft/sec**

The second factor is the pitching inertia of the aircraft which increases dramatically while the restoring aerodynamic forces grow much slower. Although the dynamics of the HP03-2 pitch oscillation while in forward lifting flight are quite complex, a dominant force is the pitching inertia, which grew by a factor of five over the dihedral range seen on the HP03-2 flight. Figure 9.10 graphically relates the variation of pitch inertia with dihedral.
