AEM 495 MEMO

Subject: Preliminary aerodynamics analysis of an unofficial Cessna Citation geometry

Memo: AEM495-14-M02

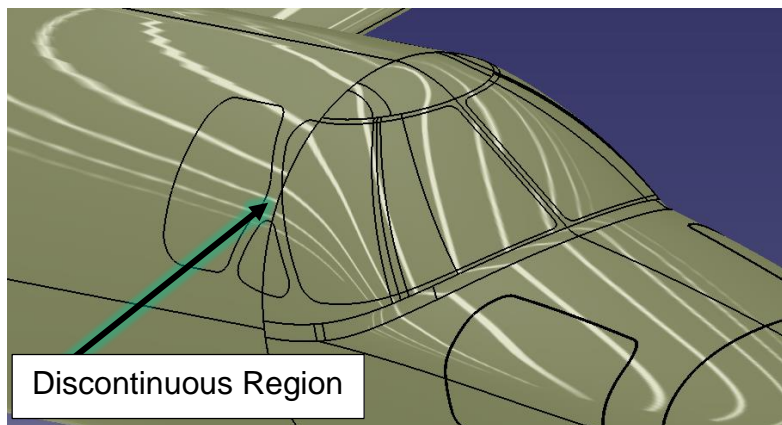
Figure 2: Canopy Loft Issue

A significant loft issue in the canopy area was spotted with zebra lighting (see Figure 2) at the intersection of the cylindrical fuselage and the complex canopy surface. From the zebra lighting, this region does **not** appear to be either tangentially or curvature constrained. **This canopy loft issue will appear as a local accelerated flow region with detrimental downstream separation.** A comparison with the actual Citation surface reveals that the current CAD model poorly represents reality.

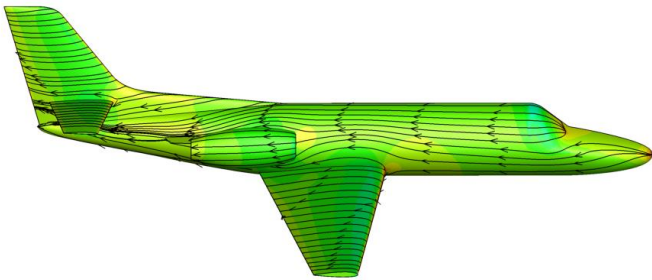
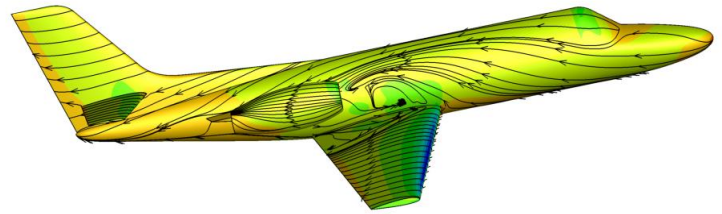
Figure 3: Mach 0.40 Streamlines

The aircraft already shows undesirable characteristics at Mach 0.40. Figure 3 shows the streamlines at 0 and 10 degrees angle of attack. Overall, the flow is attached at 0 AOA. The wing-fuselage intersection has significant issues with local flow (e.g. the stagnation point at the root is several inches along the upper wing surface); **a wing glove is needed**. The previously mentioned canopy loft issue appears as a faint blue area in the pressure contour; no separation appeared at Mach 0.40.

At 10 degrees AOA, a separated region appears in the wing root area. Unfortunately, this separation is likely to have a strong negative impact on the jet intake. At higher power settings and higher AOAs, strong separation will likely be entrained by the intake. Again, a **careful redesign of the wing root region** will be required.

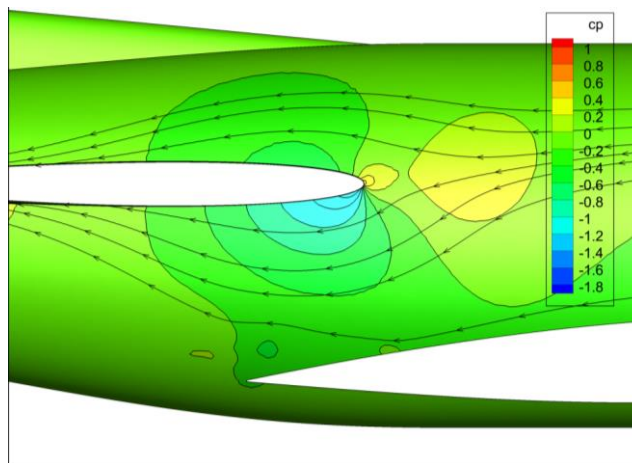
Figure 4: Pylon Streamlines and Pressures (Mach 0.40, 0 AOA)

The pylon region connecting the engine nacelle and the aft fuselage also exhibited poor aerodynamic behavior. Figure 4 shows the streamlines and pressure contours on the aft fuselage in the pylon region at Mach 0.40 and 0 AOA. The pylon is situated in a downwash region of the aft wing, resulting in an excessive suction peak on the lower surface. At other conditions, a shock appeared in this area. **The pylon must be redesigned.**

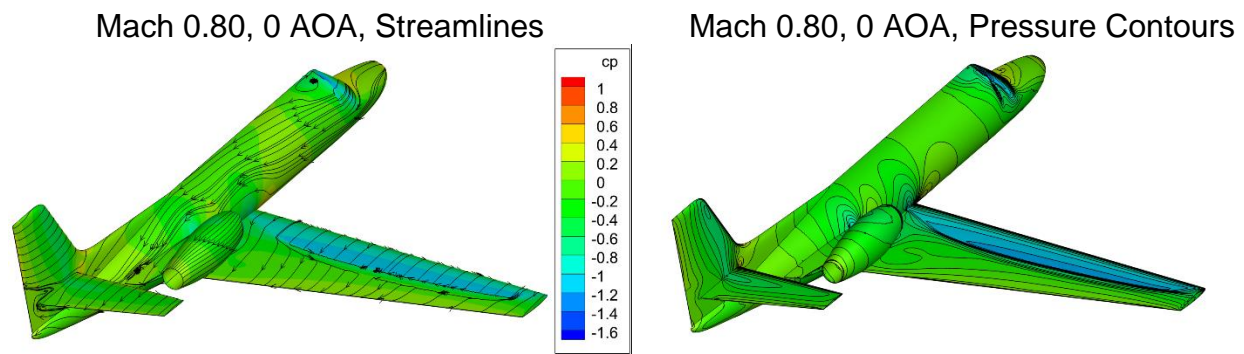
Figure 5: Mach 0.80 0 AOA Streamlines and Cp Contours

Testing at Mach 0.80 brought out additional aerodynamic issues. At 0 AOA, a strong shock is seen on the wing, upper pylon, upper canopy, and lower horizontal. See Figure 5 for streamlines and pressure contours at Mach 0.80 and 0 AOA. The upper canopy region is particularly bad. The adverse pressure gradient (i.e. shock) associated with the non-tangential surface produces a strong separation region. This local shock and separation will produce excessive noise and vibration on the aircraft.

The wing pressure contours indicate that the airfoil cross sections are likely from the classical NACA series. **These current airfoils are potentially unsatisfactory for high subsonic transport aircraft.** Also, these airfoils appear to contribute to the detrimental degradation in the pitch stability in the Mach 0.70 to Mach 0.90 range.

The current aircraft geometry is neither suited for a low speed nor a high speed wind tunnel test. It is recommended that a CAD redesign be conducted before additional testing or expense.
