AIRCRAFT ACCIDENT REPORT

TRANS WORLD AIRLINES, INC.,
BOEING 727-31, N840TW
NEAR SAGINAW, MICHIGAN
APRIL 4, 1979

NTSB-AAR-81-8

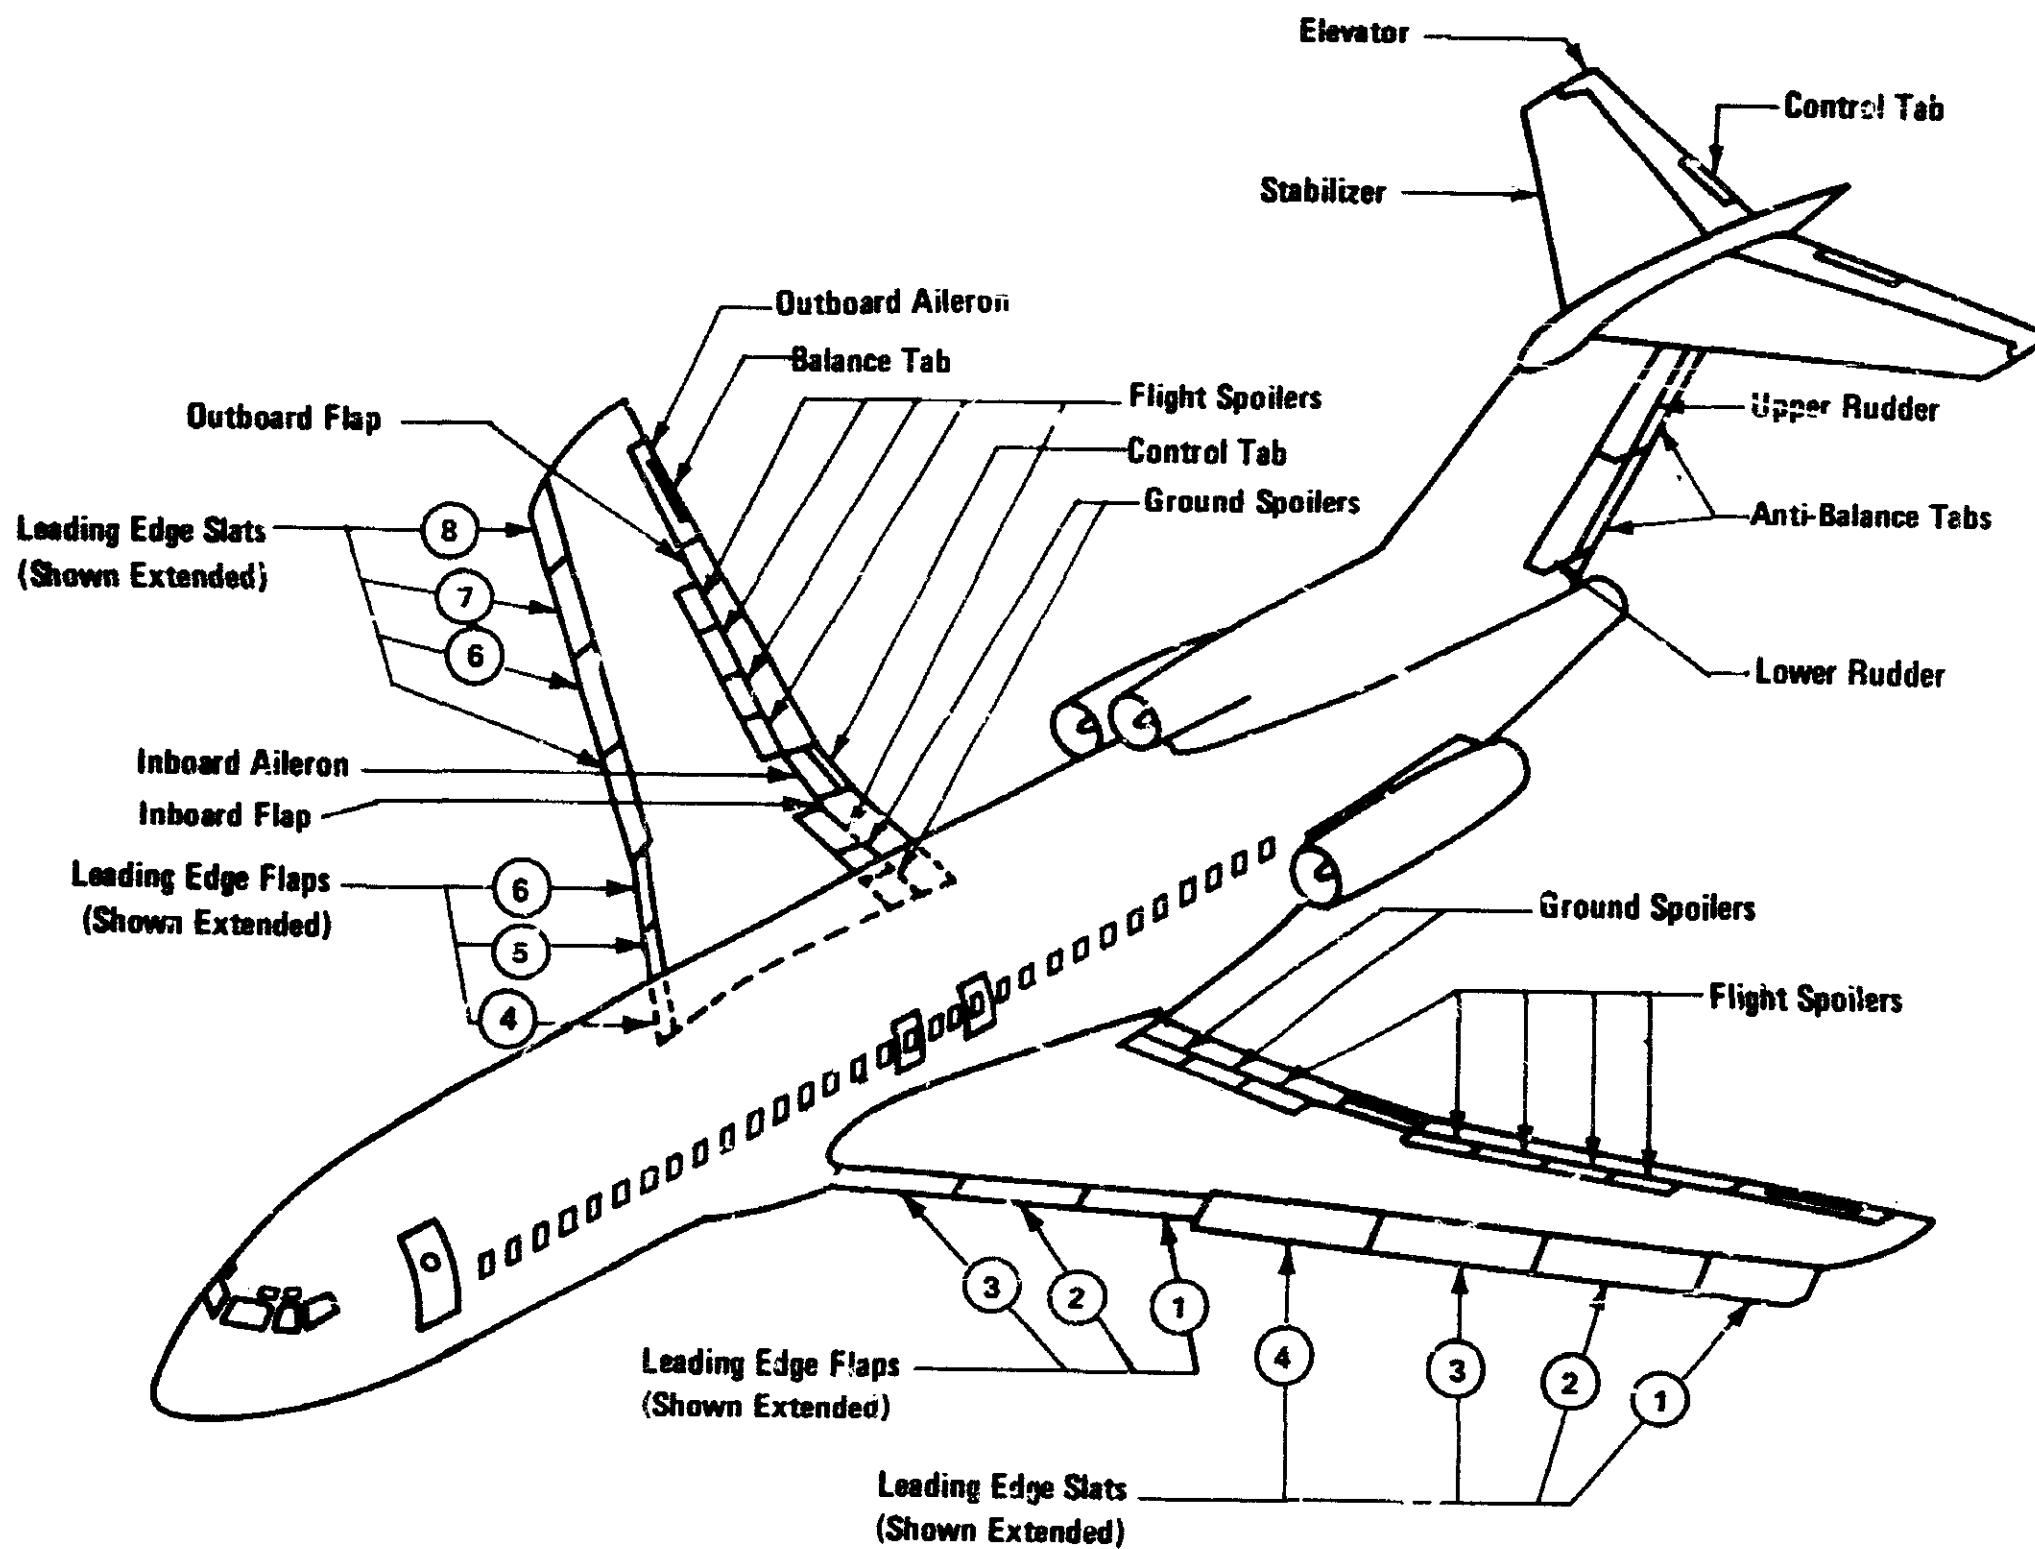
Figure 1.—B-727 flight control system surfaces.

The B-727 has eight individual leading edge slats and four individual leading edge flaps. The slats are mounted on the outboard positions of the wings and are numbered 1 through 4 on the left wing and 5 through 8 on the right wing. The flaps are on the inboard portion of the wings. (See figure 1.) The leading edge slats and flaps are high lift devices that are extended for takeoff and landing. (See figure 2.) According to the TWA Flight Handbook, the maximum speed and altitude with the leading edge devices extended are 240 knots and 25,000 feet, respectively, and the maximum speed for extension and retraction is 230 knots.

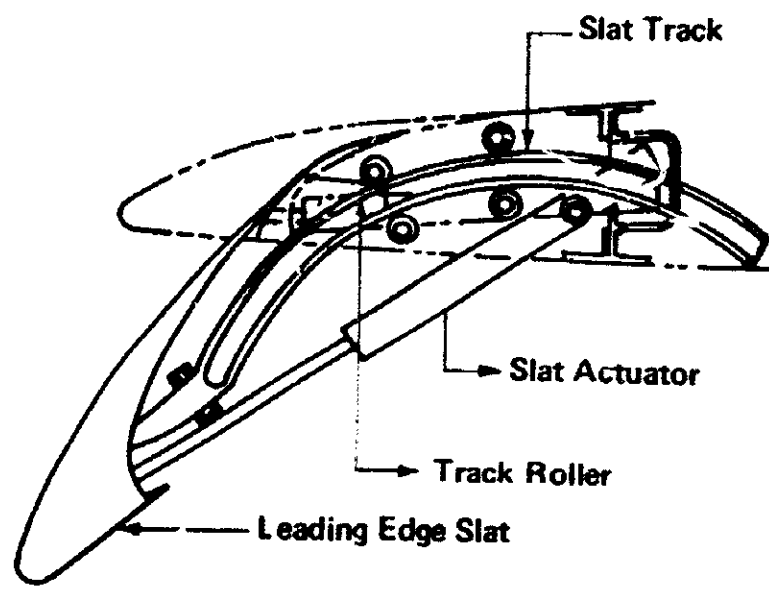
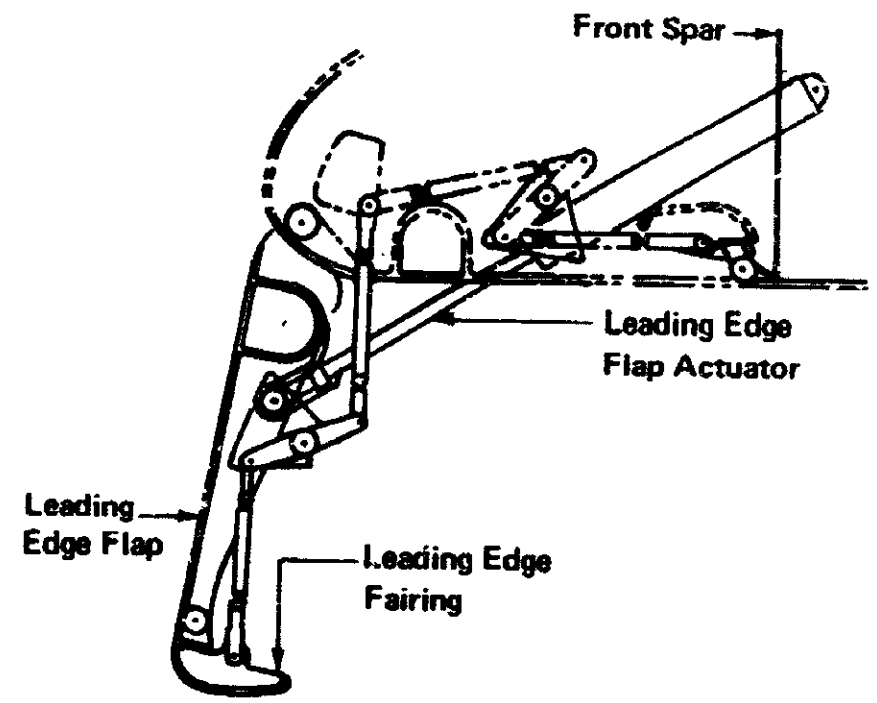
Figure 2.—B-727 wing leading edge devices.

The leading edge devices normally extend and retract in conjunction with the trailing edge flaps. The normal schedule is for extension of the Nos. 2, 3, 6, and 7 leading edge slats in conjunction with the selection of 2° of trailing edge flaps and extension of the No. 1, 4, 5, and 8 slats and the six leading edge flaps in conjunction with the selection of 5° of trailing edge flaps. The devices are retracted in the same groups in the reverse order of extension. Actual extension and retraction are initiated by the outboard trailing edge flap followup system; that is, slat extension is not initiated until the trailing edge flaps approach the 2° and 5° positions and slat retraction occurs when the trailing edge flaps retract from the 5° and 2° positions. Normal extension and retraction times for the leading edge devices is about 6 seconds.
