## AIRCRAFT ACCIDENT REPORT

In-flight Breakup Over the Atlantic Ocean  
Trans World Airlines Flight 800  
Boeing 747-131, N93119  
Near East Moriches, New York  
July 17, 1996

**NTSB/AAR-00/03  
DCA96MA070  
PB2000-910403  
Notation 6788G  
Adopted August 23, 2000**

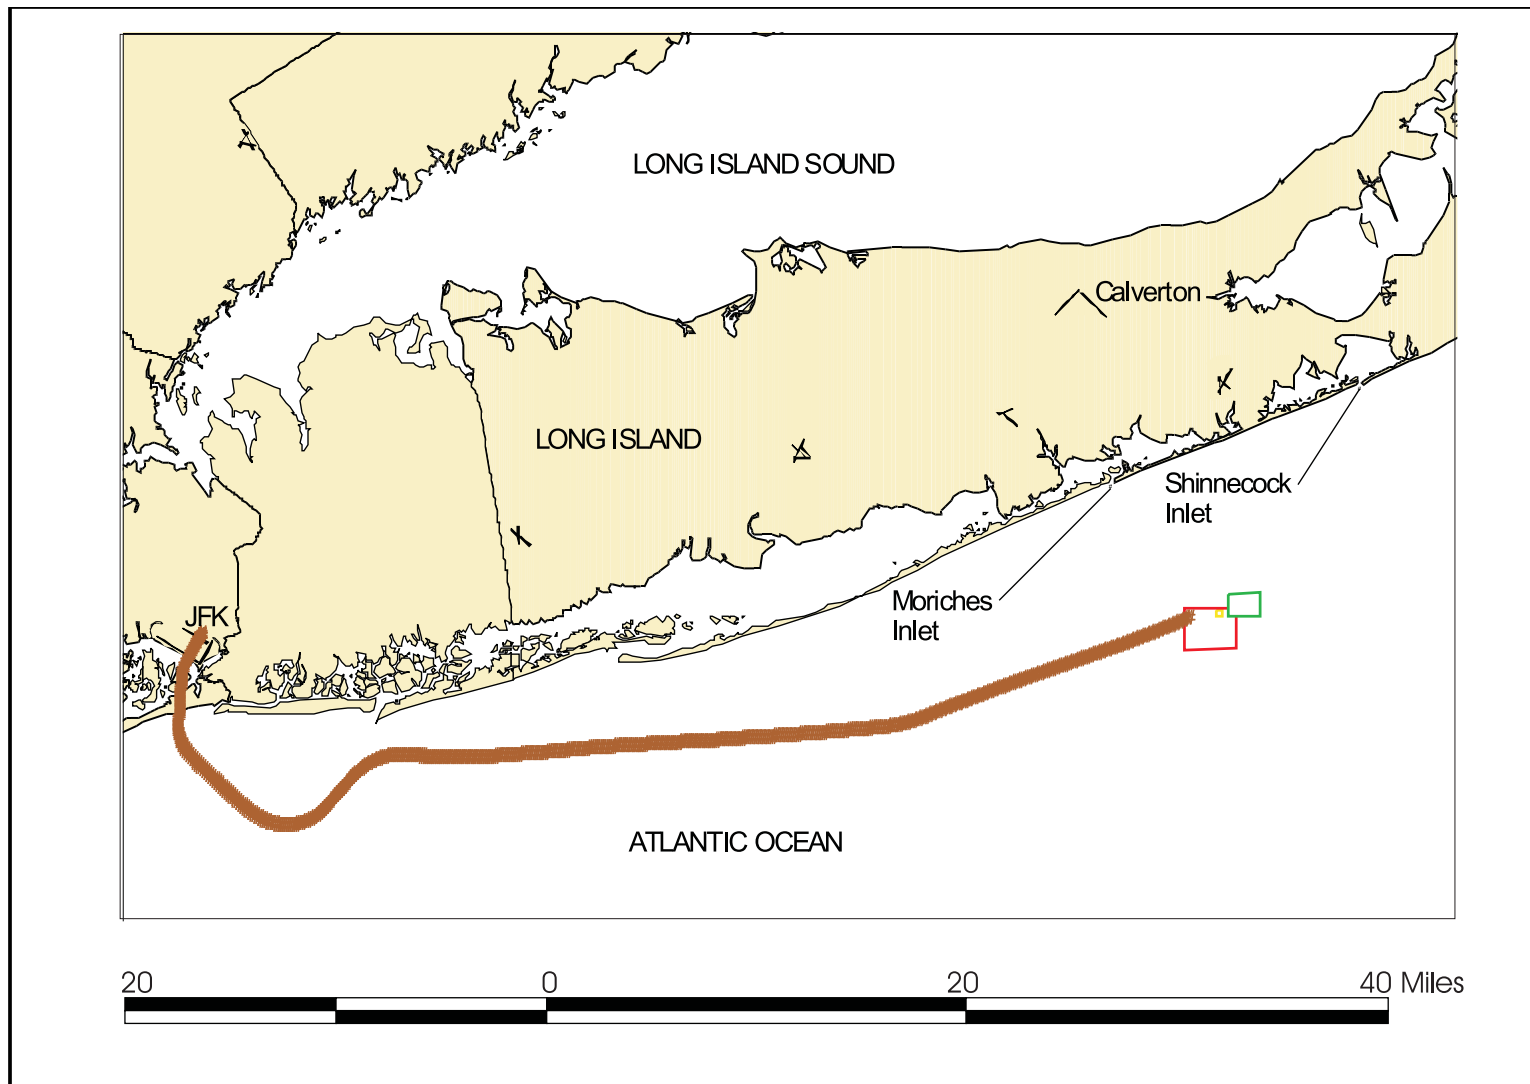
Figure 21. The wreckage location relative to the airplane's flightpath, JFK, and Long Island.

Pieces of the wreckage were distributed along a northeasterly<sup>123</sup> path about 4 miles long by 3 1/2 miles wide in the Atlantic Ocean off the coast of Long Island. (Figure 21 shows the wreckage location relative to the airplane’s flightpath, JFK, and Long Island.)

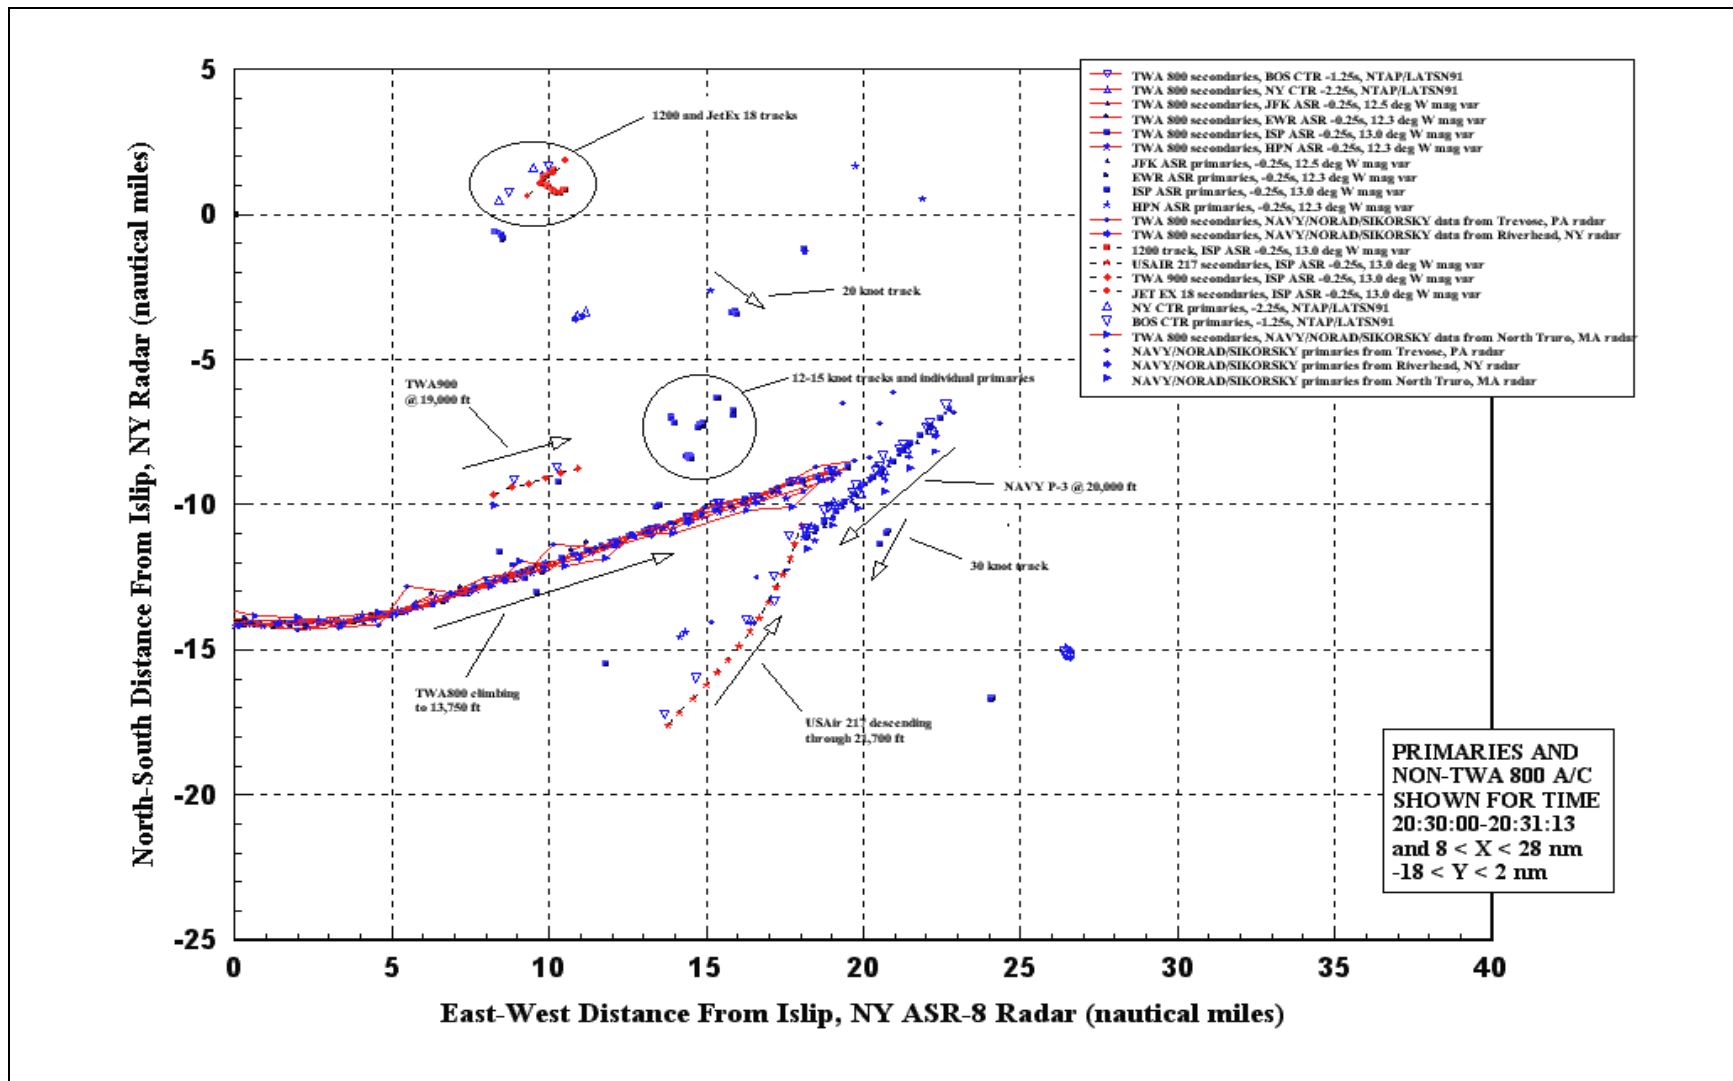
Figure 25. Radar data showing vehicle and/or object tracks within 10 nm of TWA flight 800 just before the accident.

Examination of the radar data showed the following vehicle and/or object tracks within 10 nm of TWA flight 800 just before the accident (see figure 25):

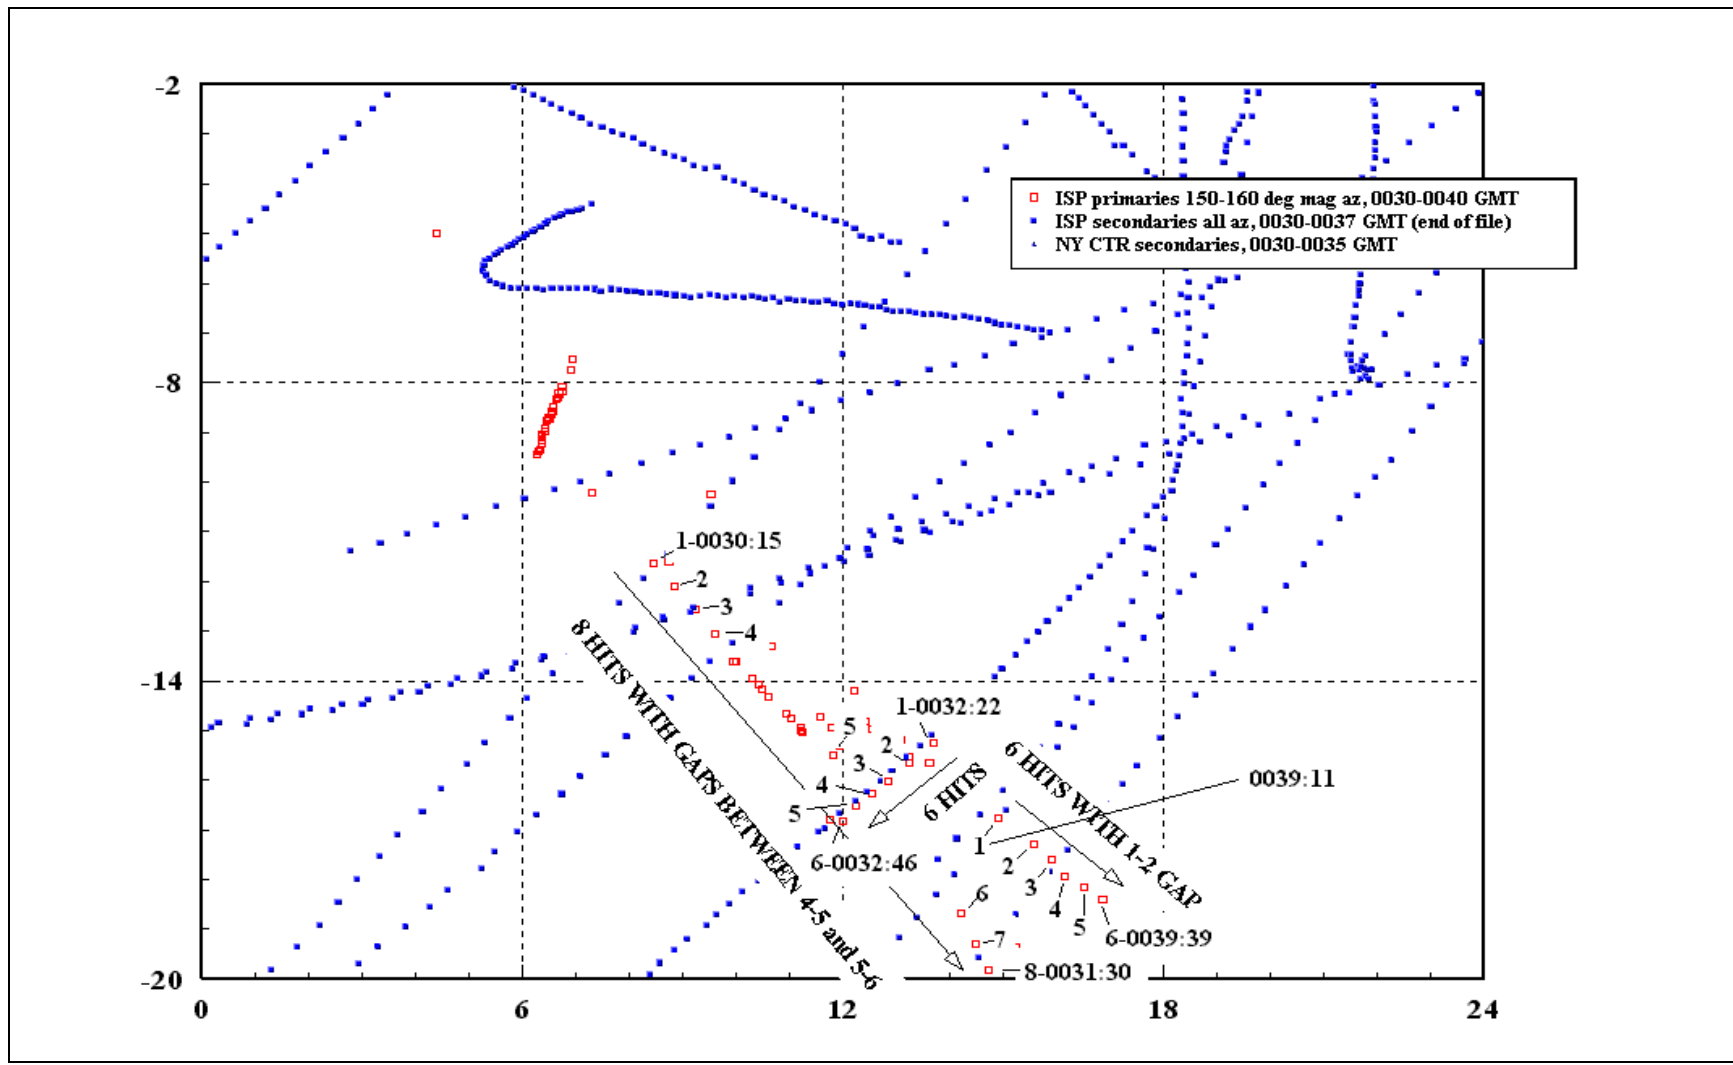
Figure 27. Sequence of eight primary radar returns recorded by the Islip, New York, radar site about the time of the accident.

Although most of the radar systems from which the Safety Board obtained data were capable of recording radar targets in the geographic area in which these primary radar returns were recorded, this sequence of eight primary radar returns was only observed in the data from the Islip radar site. Further examination of the returns recorded in that geographic area by the Islip site between about 2030 and 2040 revealed two additional sequences of primary radar tracks with apparent ground speeds greater than 300 knots. One of these sequences indicated a radar target movement away from TWA flight 800 to the southeast, whereas the other sequence indicated a target movement away from TWA flight 800 to the southwest.

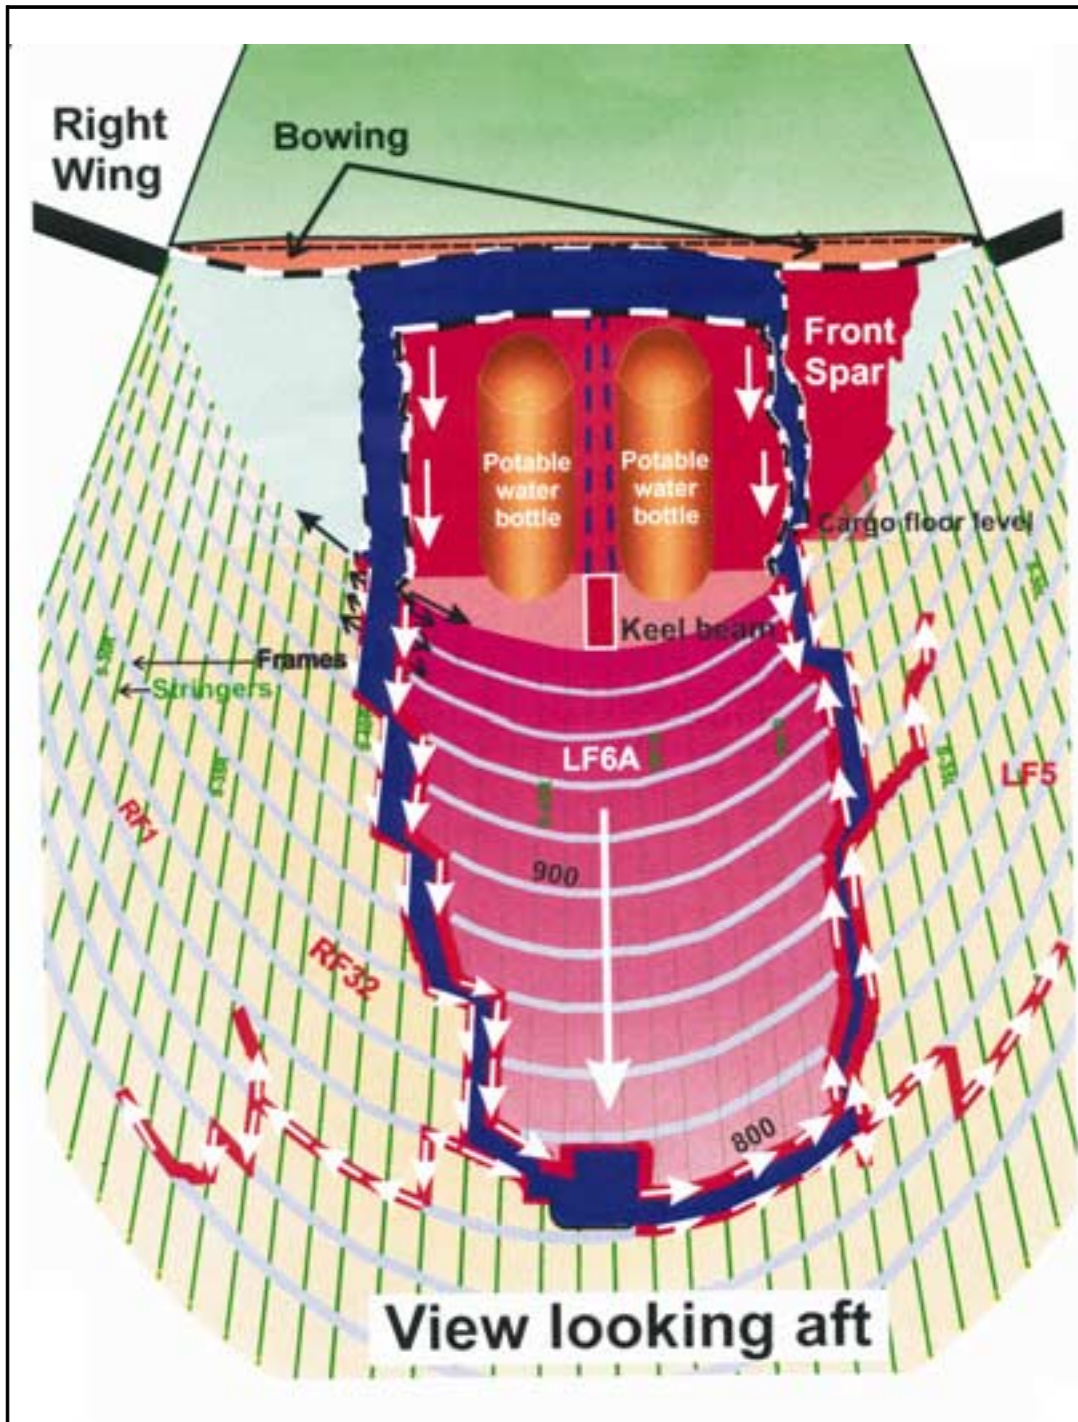
The detailed examinations of the fuselage red zone pieces are an example of how these examinations were successful in determining an important segment of the breakup sequence. Figure 30 shows a schematic drawing of the lower portion of the fuselage skin in the area forward of the front spar. In this figure, the earlier fuselage skin fractures have been highlighted, and arrows have been added to indicate the direction of cracking in these earlier fractures. Of all of the fuselage fractures examined, only a limited number (all of which were on pieces recovered from the red zone) could be classified as earlier fractures (that is, consistent with in-plane loading). Further detailed examination of the rivet-to-rivet fracture pattern in these earlier fuselage fractures generated information on crack propagation directions and indicated that the earliest fracturing was of the lower fuselage, beginning at the front spar of the WCS. (The methodology used to determine the sequence of fracture in the fuselage red zone pieces was typical of the approach used for the entire airplane structure.)

Figure 30. A schematic drawing of the lower portion of the fuselage skin in the area

The Sequencing Group determined that the upper chord of the front spar then completely separated from the WCS upper skin panel, and the overpressure within the CWT forced the WCS lower skin panel and the forward end of the keel beam downward. Stress analysis performed as a part of the sequencing study showed that the continuing downward keel beam motion increased the stresses in the ring chord and fuselage skin adjacent to the front spar. The front spar stiffener at LBL 18 was not bent as far forward as the others, indicating that there was limited forward rotation of the front spar in this area before the ring chord separated at the bottom of the stiffener. Fractures on the right side of the front spar continued into the lower pressure bulkhead,<sup>201</sup> then continued through the ring chord and into the fuselage skin just in front of the front spar, at stringer 40 right (see figure 30).

On the basis of cracking directions of the fuselage skin, the Sequencing Group determined that the initial fuselage skin cracking (at stringer 40 right just forward of the front spar, about STA 1000) propagated forward and toward the bottom center of the airplane, then continued circumferentially in both directions and back toward the front spar on the lower left side. This fuselage cracking then quickly progressed<sup>202</sup> around three sides of a large piece of fuselage belly structure (subsequently identified primarily as piece LF6A). See figure 30 for a diagram of this cracking in the fuselage; piece LF6A is located in the center of this figure.

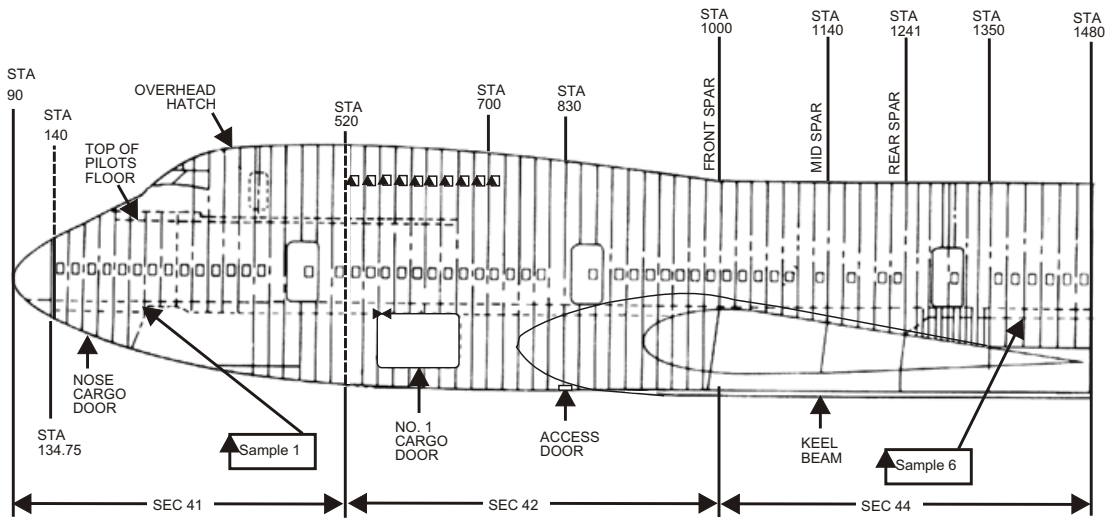
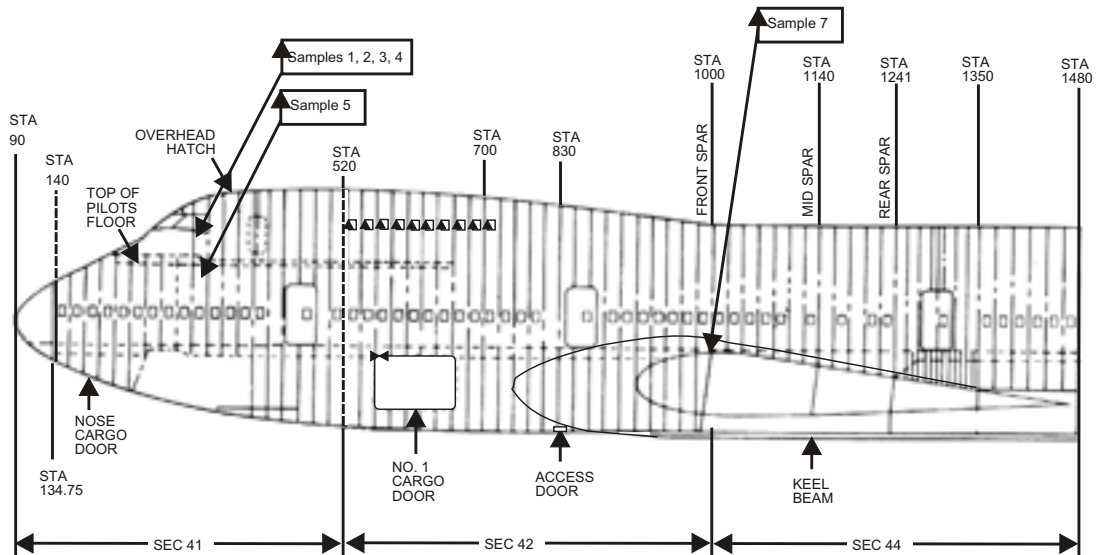
4. The weak point in this wire type appears to be the lack of ability to maintain physical and electrical integrity during extended elevated thermal exposure with mechanical stress. As the wire ages, there is an increased risk of dielectric problems [breakdown of wire insulation integrity], mechanical damage and loss of electrical integrity.
5. No wire was submitted that was exposed to high levels of environmental exposure (such as wires from wheel wells, wing leading edges, etc.). Wire from these areas, would be expected to perform worse than the wire submitted. [See figures 35a, 35b, and 35c for sample locations.]

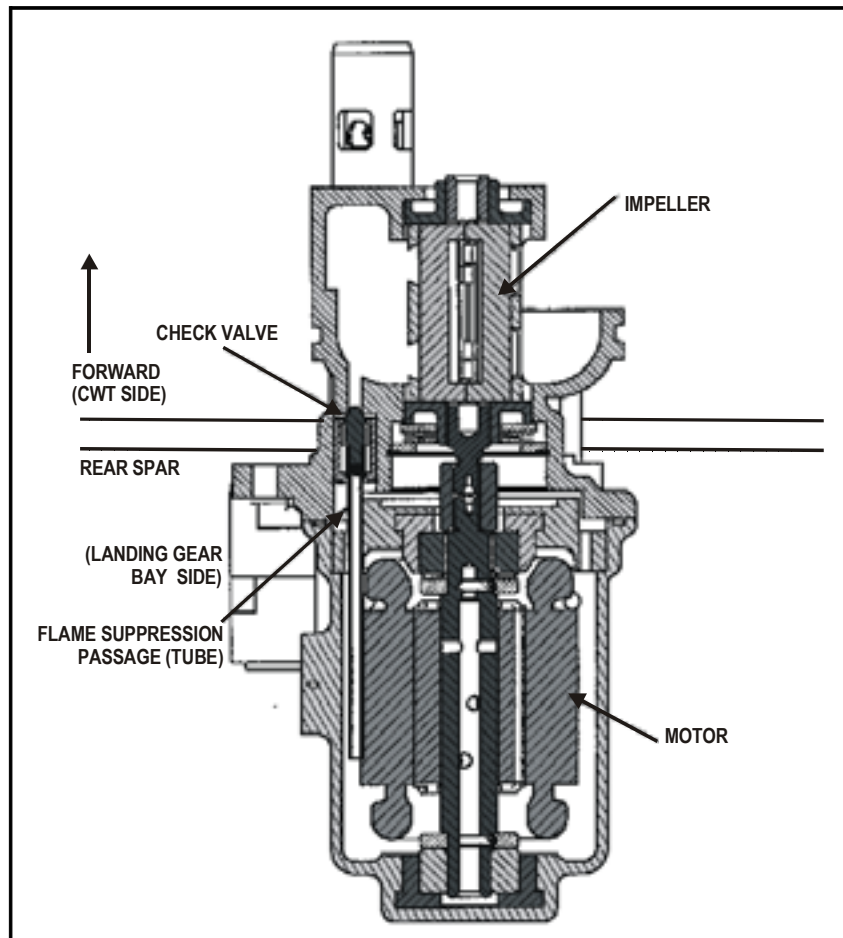
contained multiple explosions that were intentionally ignited within the pump motor cavity, preventing the ignition from transferring to the fuel tank. (Figure 37 is a diagram of a scavenge pump.) Because the Board became aware of instances in which the flame arrestor tube was broken or missing, investigators also conducted a series of tests to determine whether the scavenge pump motor housing would contain explosions with only one of the flame suppression system components (either the flame arrestor tube or the check valve) functioning. In all tests, the scavenge pump housing contained the explosions, and the explosive atmosphere surrounding the test pump did not ignite.

During its postaccident examination of other transport-category airplanes, the Safety Board observed that components in the electrical connector on a scavenge pump in a retired 747 were deteriorated. (Boeing ASBs 747-28A2194 and 747-28A0043, both dated January 18, 1996, “encouraged” operators to inspect for degradation in connectors.) Investigators observed that several scavenge pump electrical connectors had been manufactured of a material that degraded with long-term exposure to fuel. Boeing provided the Board with a service history for the 747 scavenge pump for the 10 years preceding the accident. When queried about the brevity of this history, Boeing indicated that most operators did not return the scavenge pumps to the manufacturer for overhaul.

**Figure 37.** A diagram of a scavenge pump.

As a result of these findings, Boeing issued ASB 747-28A2206, dated September 25, 1997, and AD 97-25-06, effective December 16, 1997. AD 97-25-06 contained the following summary:

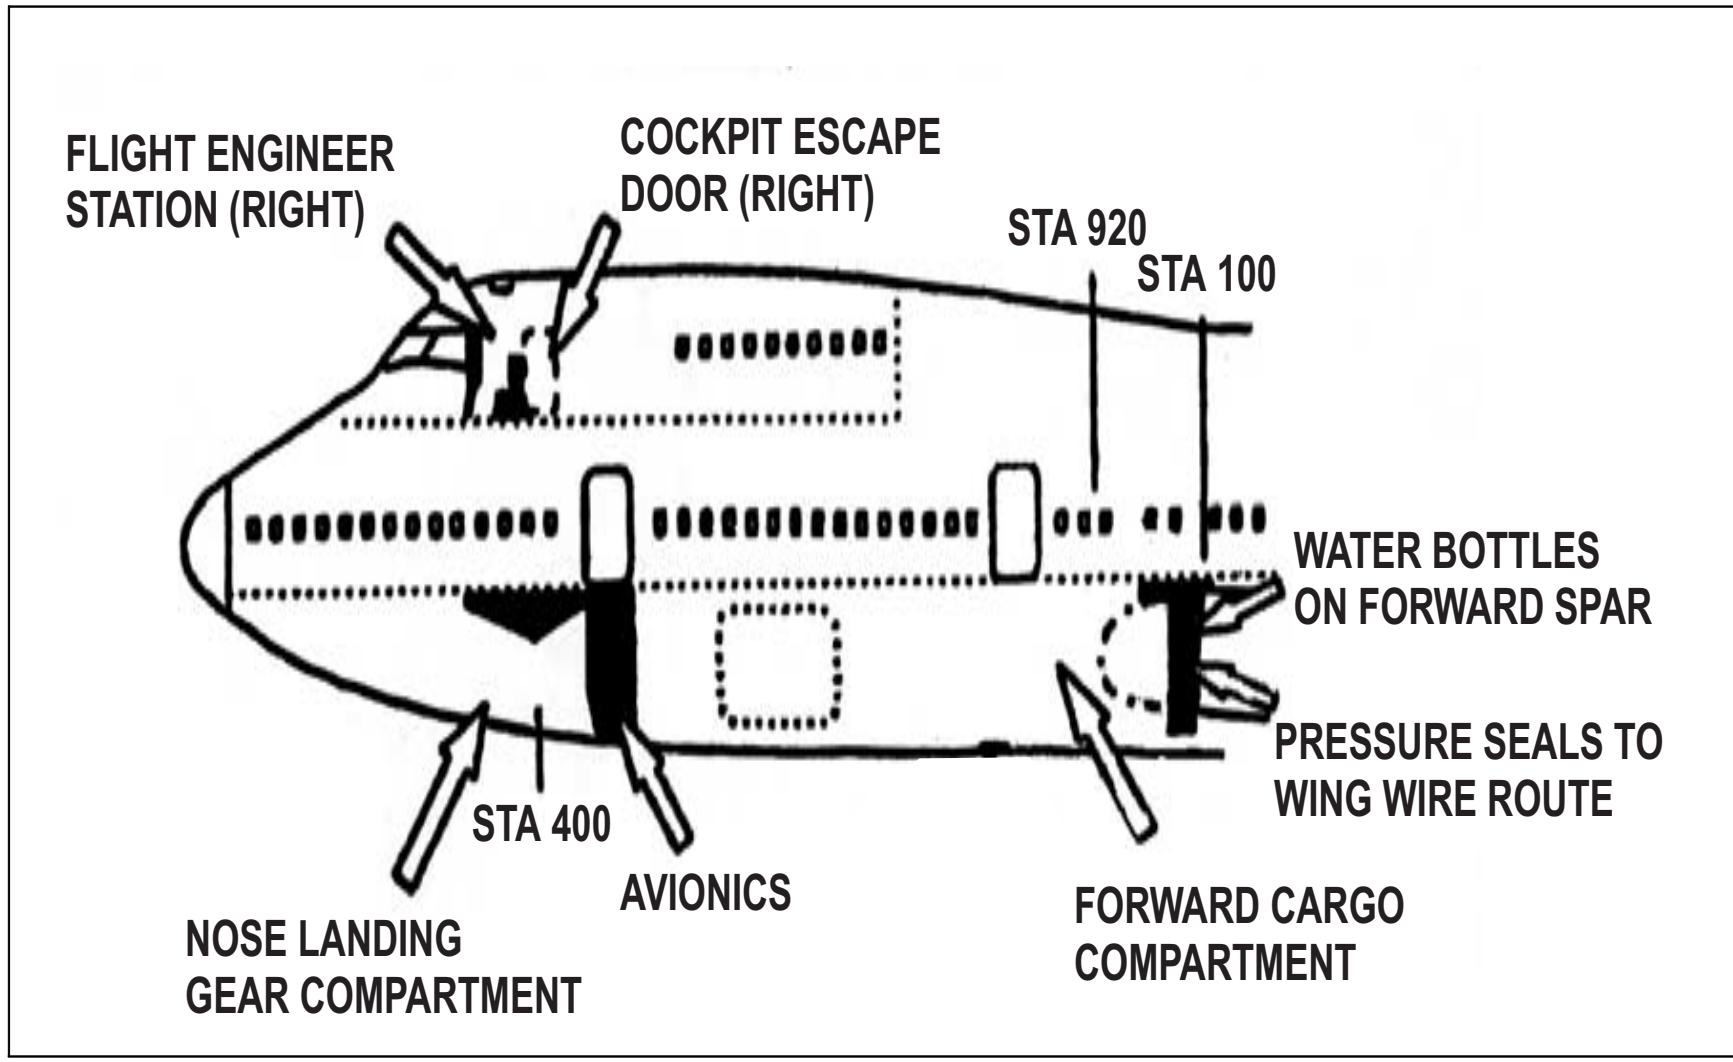
**Figure 38.** Diagram showing the areas typically inspected on 747 airplanes.

In one airplane (its last known flight was in January 1997), wires in the raceway over the CWT were not bundled (as indicated by Boeing's PIs) but were randomly laid in a tray, such that individual wires crossed from one side of the tray to the other. Higher-voltage generator and galley power cables were clamped to the adjacent structure (not routed in the tray). Inspection of the inside of this airplane's CWT revealed the following: the scavenge pump inlet screen contained a nearly 1-inch-long uninsulated wire fragment, a vertically routed FQIS wire was chafed where it contacted a horizontal structural flange, and a horizontally routed FQIS wire was chafed where it contacted a vertical row of rivets between two supporting clamps. Examination of this airplane's CWT fuel quantity probes by the AFRL experts revealed sulfide deposits on the bare wire ends and terminal sleeves, and some of the wires were loose under the clamps; two of the wires exhibited striation marks that resembled jaw marks of a wire stripping tool.

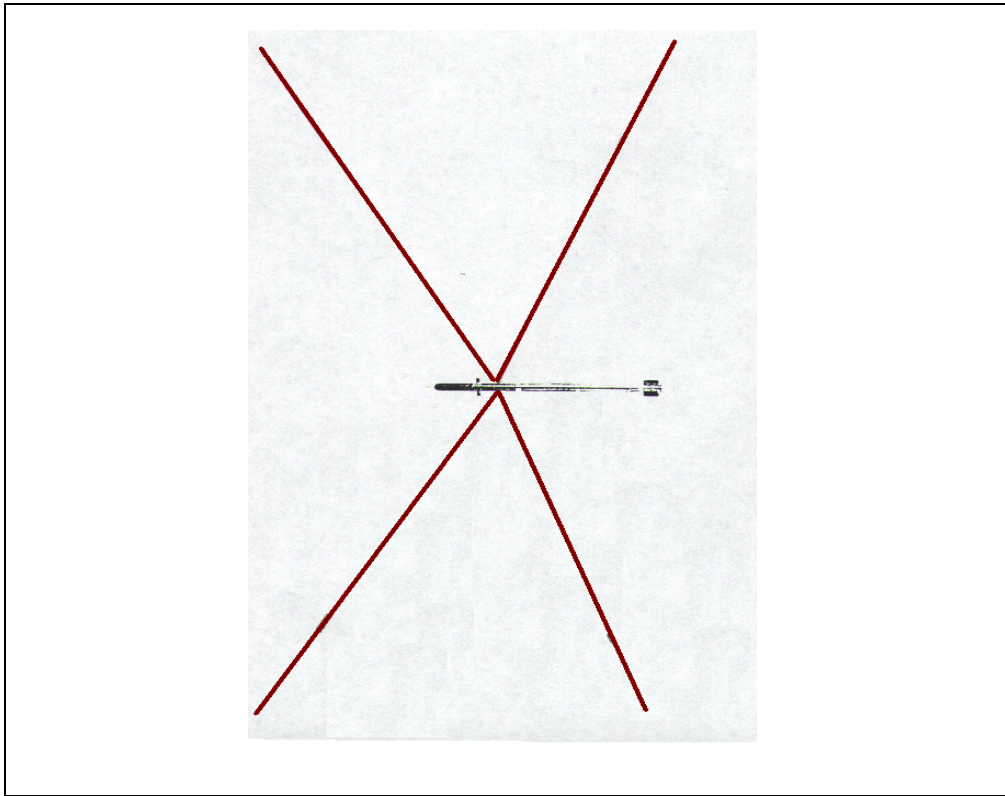
According to the MSIC, warhead detonation typically results in about 1,000 fragments of various sizes, with an average mass of less than 10 grains (0.0229 ounce), and a mass as large as 40 grains (0.0916 ounce) in the pattern shown in figure 43. MSIC reported that warhead fragments could have an initial velocity of up to 9,000 fps. Data obtained from the SURVIAC indicated that 10- and 40-grain fragments would require velocities of 3,500 fps and 2,000 fps, respectively, to penetrate the CWT if they impacted the bottom of the CWT at a right angle. Using the initial speed and speed decay rate for the warhead fragments, the Safety Board calculated that a detonation would have to occur 40 feet or less below the airplane's CWT for a fragment to retain sufficient velocity to penetrate the CWT.

**Figure 43.** Diagram of warhead detonation fragment pattern.

Simulations further showed that, because of the pattern in which missile fragments are dispersed after selfdestruction (see figure 43), launches from many of these positions would result in no fragments having a trajectory that would result in penetration of the CWT. For example, because of the nature of missile guidance, a launch from most positions on the perimeter shown in figure 44 would result in the missile catching the aircraft from behind. The area in front of the missile is not in the fragment dispersal area.

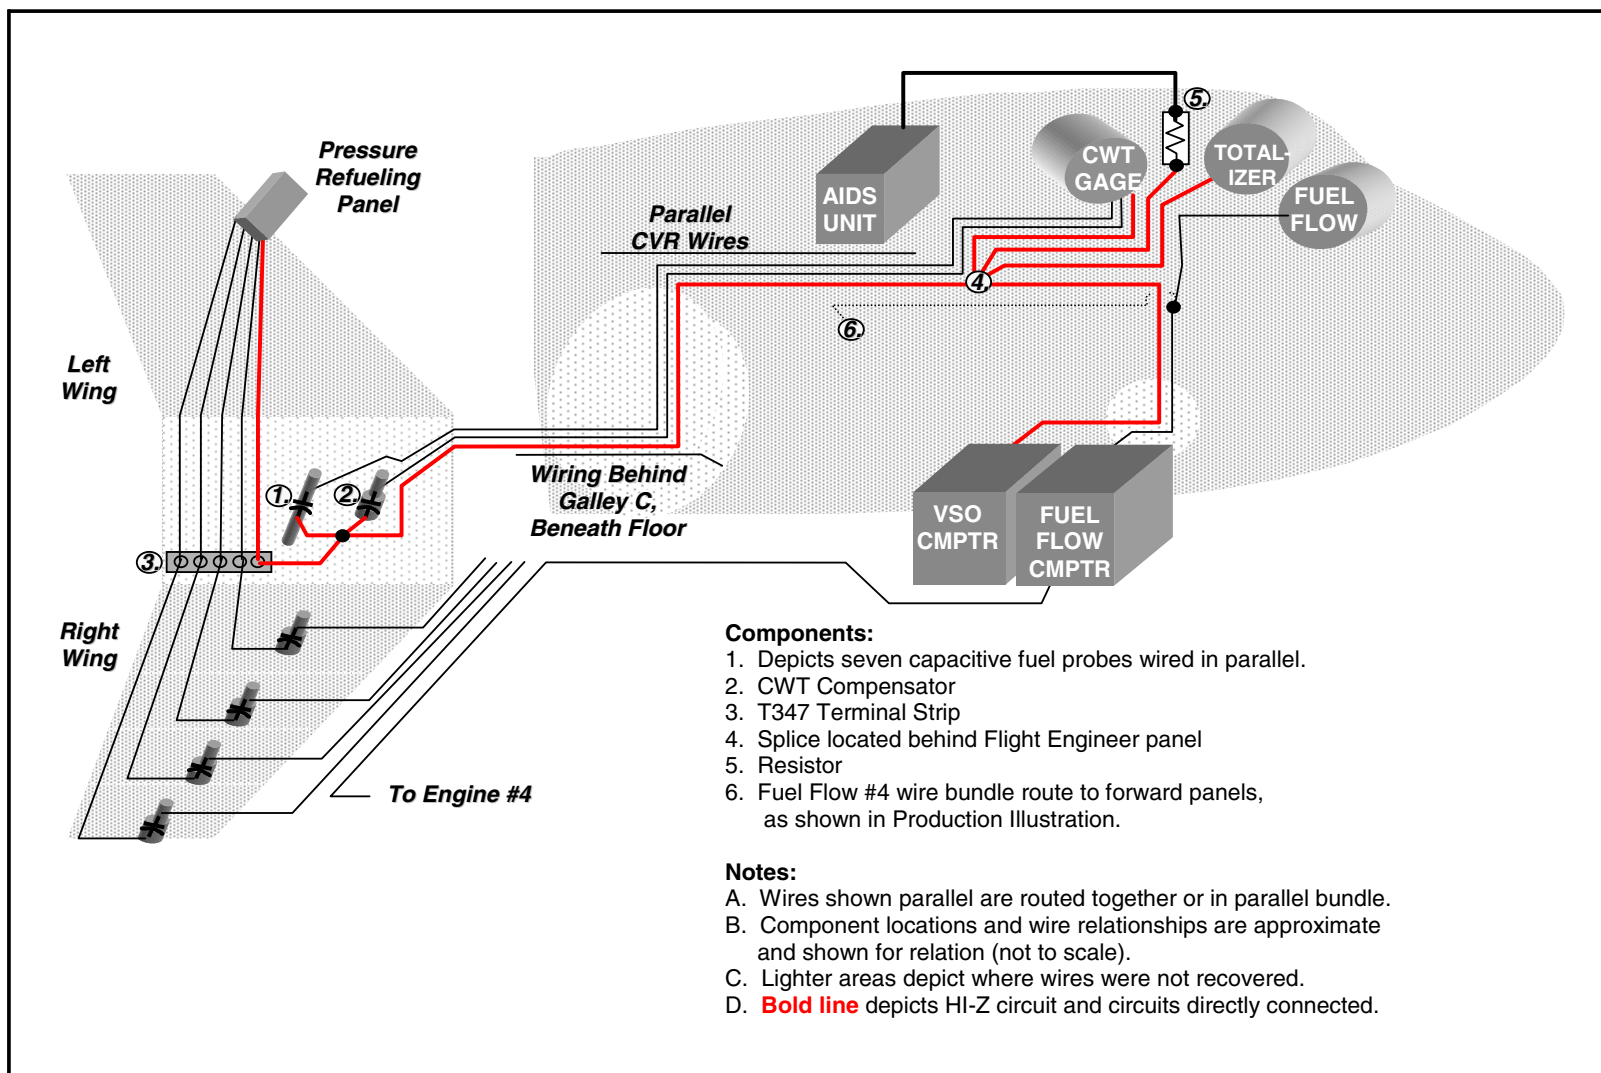
The CWT FQIS wiring in the 747 terminates at common connectors with the fuel quantity indicator, the totalizer gauge, the airborne integrated data system (AIDS), the volumetric shutoff (VSO), and the left wing refueling station; each of these connectors also includes terminating wires from circuits that carry 115 volts.<sup>605</sup> (See figure 46.) Short circuits in connectors have caused incidents in the past. For example, an October 22, 1995, incident involving roll/yaw oscillations on a 737 near Manchester, England, was attributed to a short circuit in the rudder circuitry of the incident airplane that resulted from lavatory fluid bridging the pins within an electrical conductor.

Figure 46. Diagram of the center wing tank fuel quantity indication system wiring on the 747 and its common connectors.
