AEM 495 MEMO

Subject: Preliminary aerodynamics analysis of an unofficial Cessna Citation geometry

Memo: AEM495-14-M02

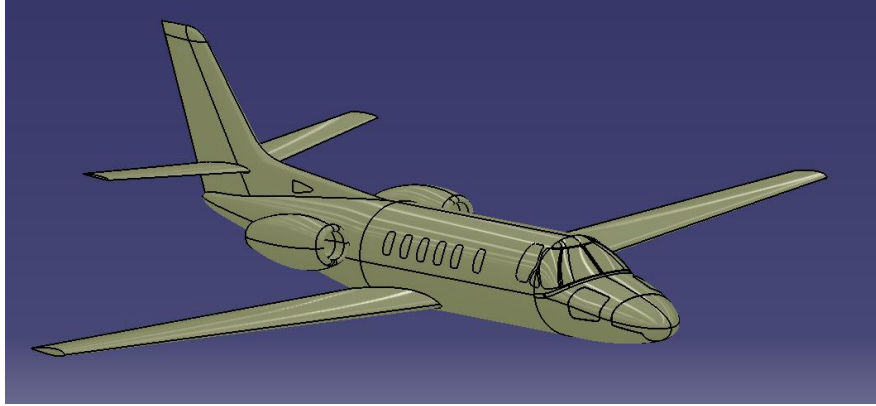
Figure 1: Citation CAD model (full aircraft)

The model was supplied in a .STEP format by GrabCAD.com. It should be noted that the loft geometry presented is **not** an official Cessna geometry; the geometry was solely determined by reverse engineering. The as-supplied model required moderate loft-cleanup and surface trimming with CATIA. The cleaned model is illustrated in Figure 1. The forward hatch area was particularly difficult as the original model attempted to represent the hatch gaps with a tangential double fillet.
