**Investigation of the  
Helios Prototype Aircraft Mishap**

**Volume I  
Mishap Report**

**January 2004**

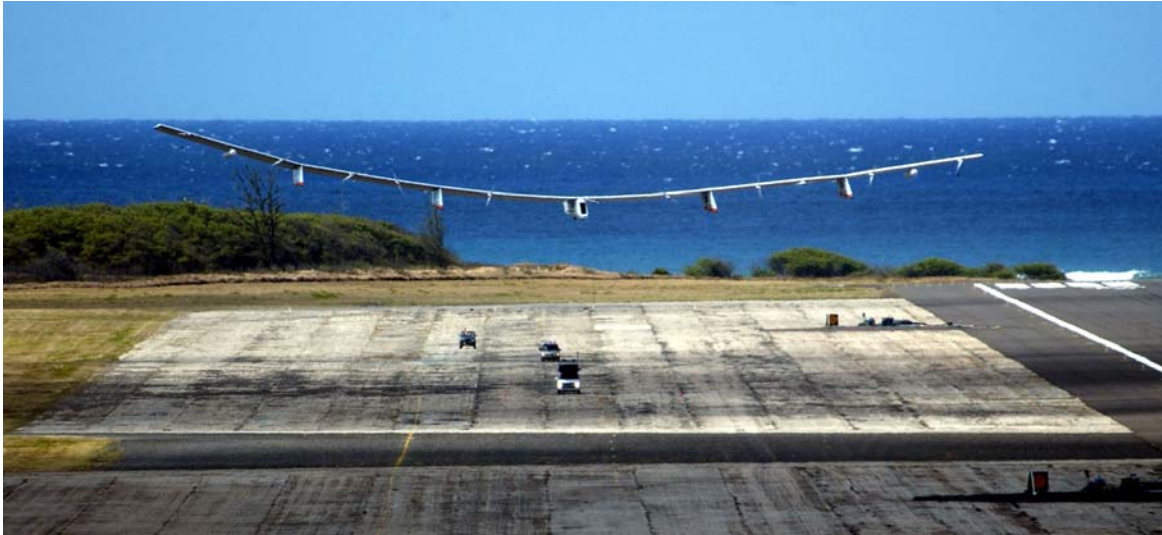
**Figure 7.2 - HP03-2 on Takeoff**

By 9:30am, a quantity ( $\sigma_w$ ) measured directly by the Sodar that is proportional to the strength of small-scale vertical velocity fluctuations and indicative of low-level turbulence risk, had increased from 0.4 m/sec to as high as 0.8 m/sec. Although these  $\sigma_w$  values did not violate mission rules of 1.0 m/sec, the Helios Meteorologist did advise the MFD that these values were the largest he'd seen for a takeoff, and high enough to expect light to moderate turbulence. After 9:38am, the  $\sigma_w$  value edged down to 0.7 m/s. In addition at 9:36am, the tower reported seeing white caps building offshore, indicative of the proximity of the shear lines. Whitecaps are clearly visible in Figure 7.2.

- 8) At 9:36am, the tower reported that whitecaps were already visible offshore, indicative of the very close proximity of the southern shear line. Whitecaps are clearly visible in Figure 7.2.

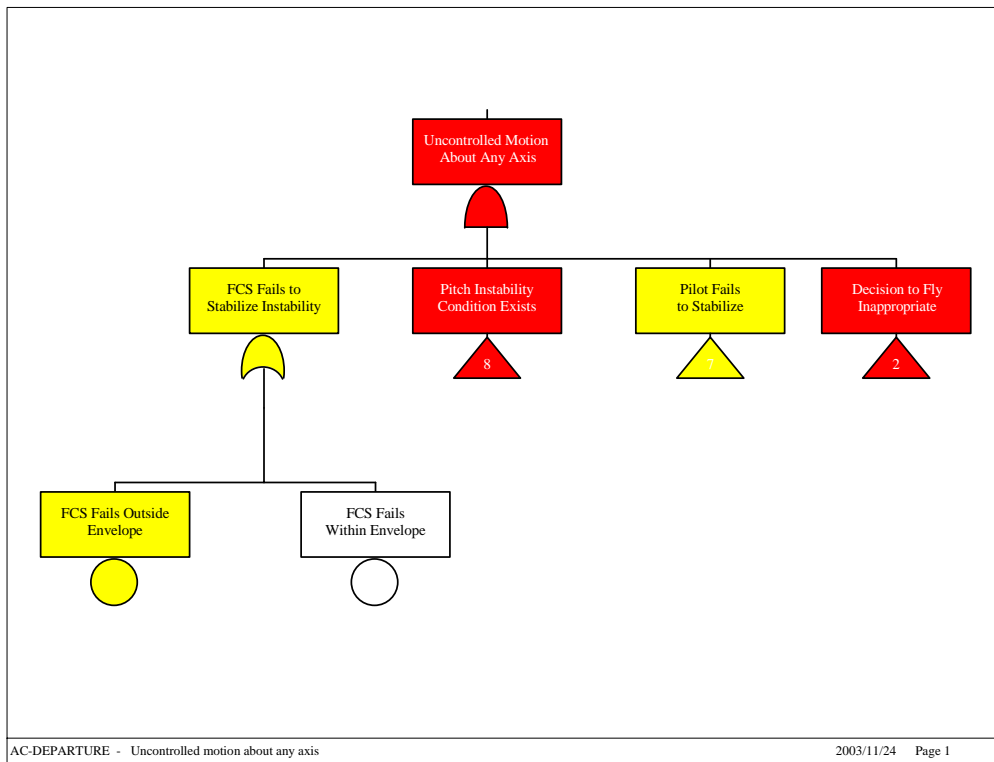
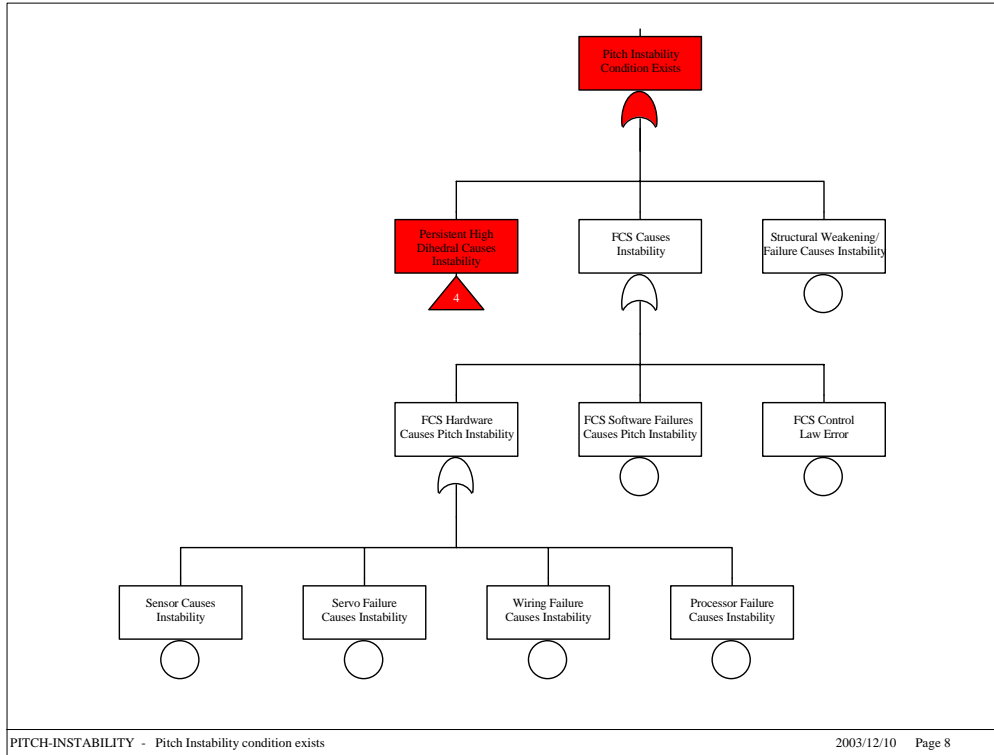
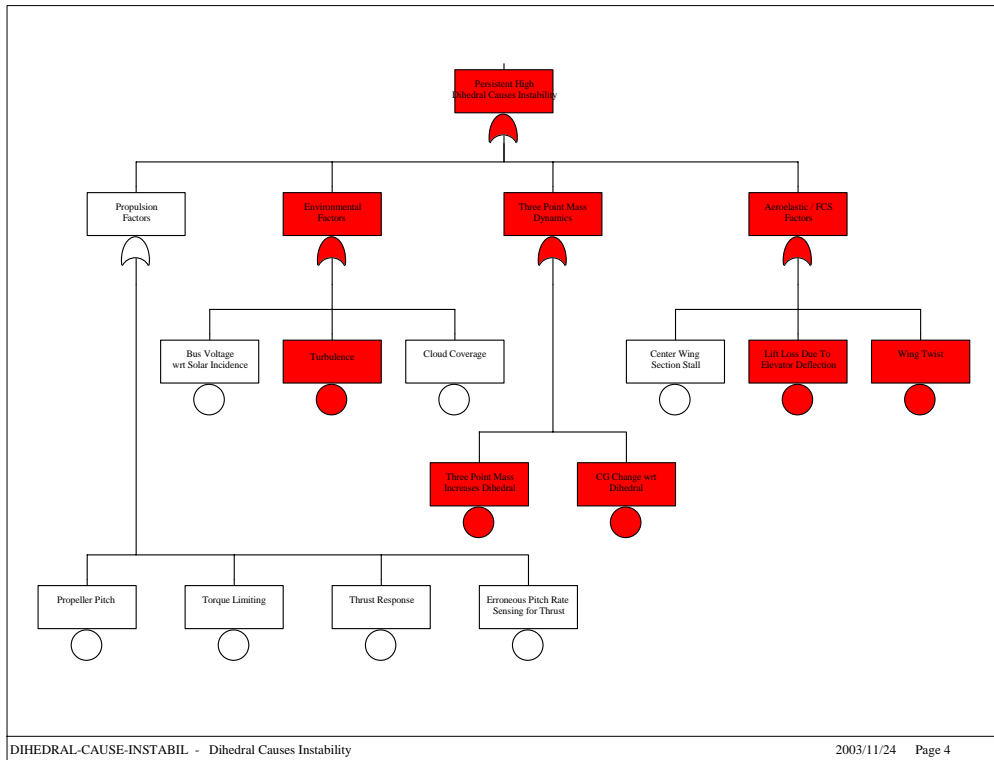
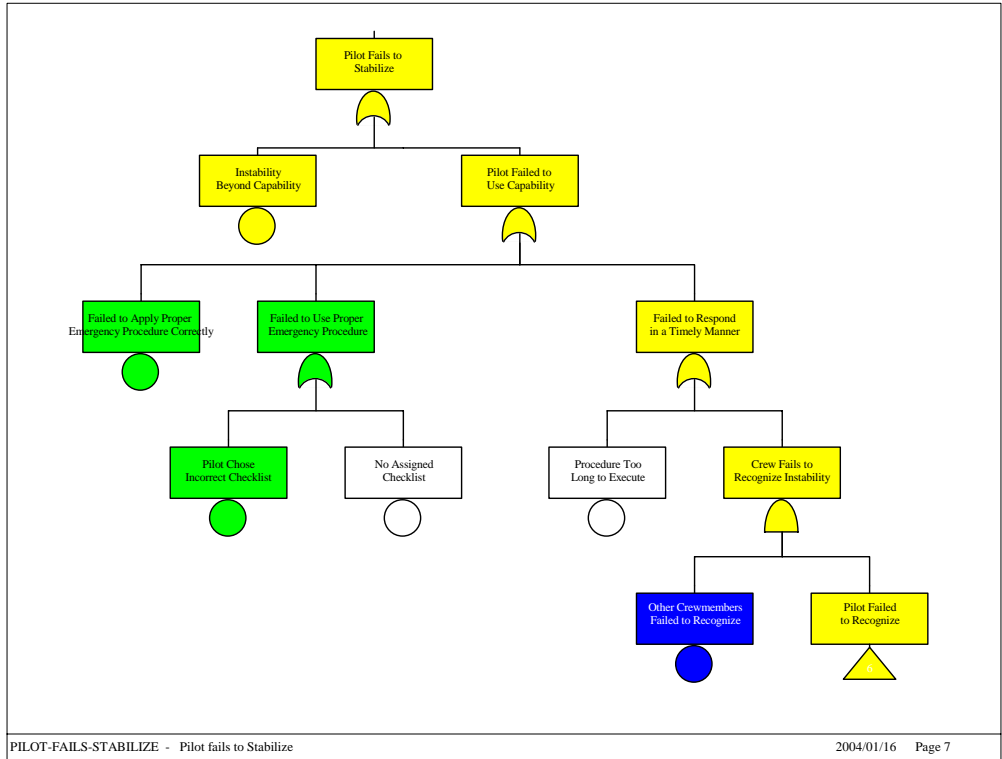
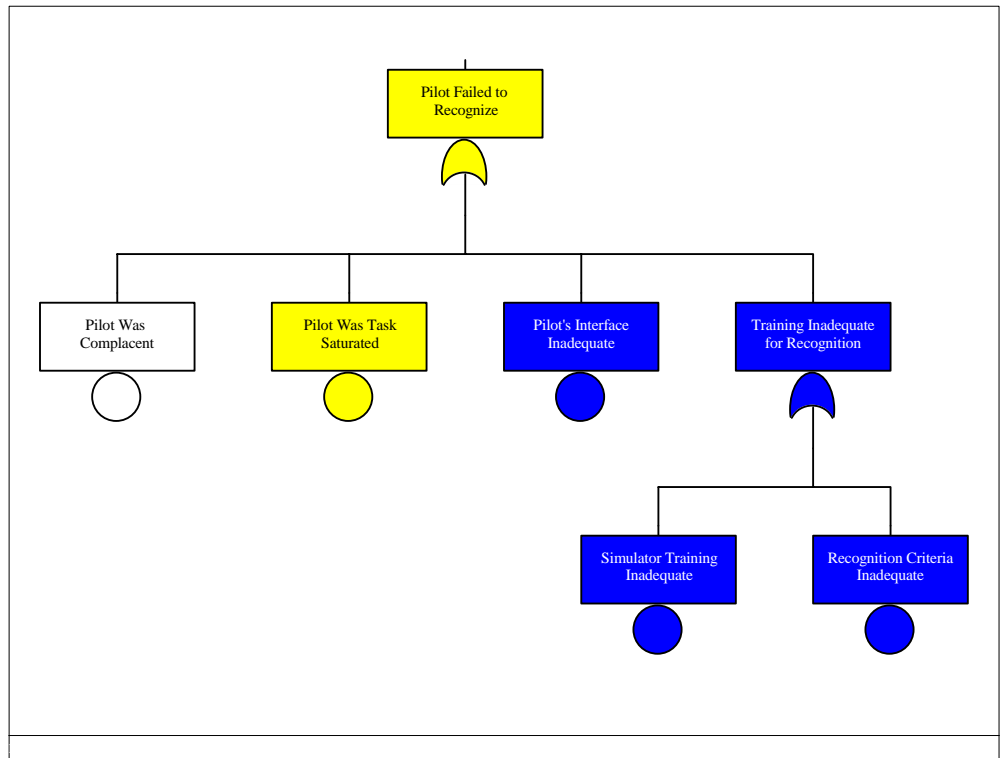
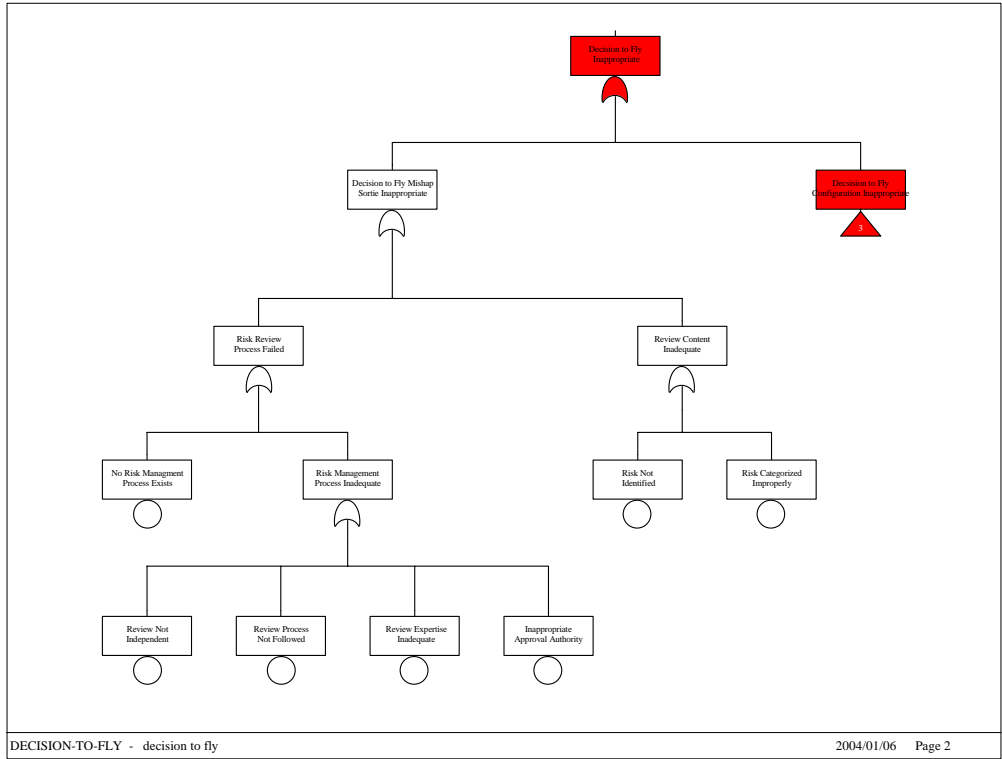
**Figure 9.2 (1 of 7) – MIB Events and Causal Factor Tree**

Figure 9.1 provides a legend to better follow the MIB Events and Causal Factor Tree shown in Figure 9.2. Color-coding correlates to the identification of root causes, contributing factors, significant observations, and findings as presented in Section 10. For example, root causes can be identified by a red colored event symbol (box with circle below). Gates, representing intermediate or summary conditions between potential causal factors and the top level event of “uncontrolled motion about any axis” are colored to reflect the most significant of the four categories of events that define it. Increasing event significance is ordered from right to left in the legend, with root causes having the greatest significance relative to the mishap.

Table 9.1 shows the Events and Causal Factor Tree in WBS format; "AND gates" are shown in **bold** and "OR gates" are shown in *italic*. Faults or events that were determined to be “true” are denoted as (T) and faults or events that were determined to be “false” are denoted as (F). Further details describing each element of the Events and Causal Factor Tree are provided below and in many cases, a reference that presents additional evidence as to the path being declared “True” or “False” is provided.

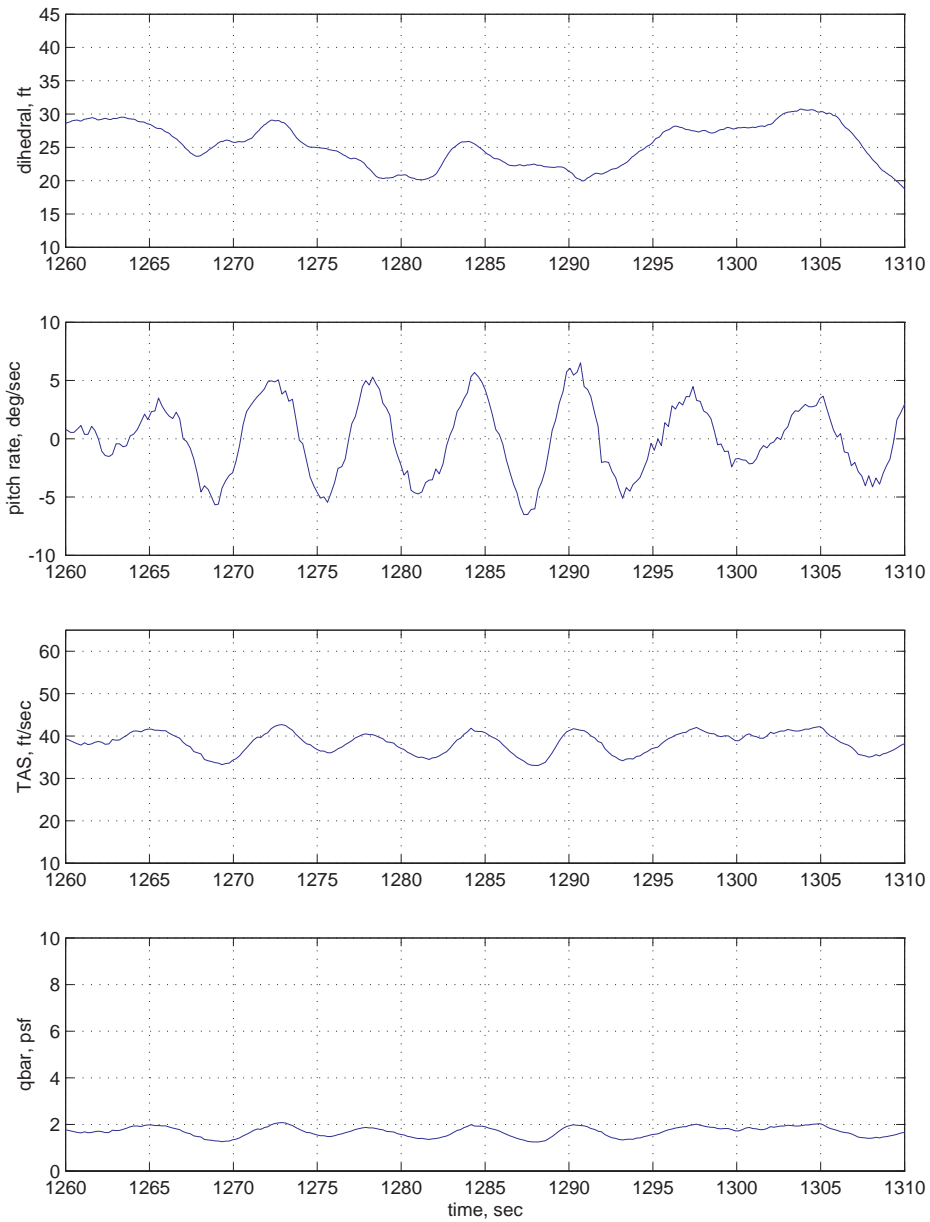
**Figure 9.7 - Dihedral, Pitch, Vehicle Airspeed, and Dynamic Pressure for Event 1**

It is concluded that the persistent high dihedral caused the pitch instability. The pitch oscillation shares many characteristics with a traditional neutrally damped phugoid response of conventional fixed wing aircraft. For the Helios, the period of the neutrally damped pitch oscillation was about 8 to 9 seconds and the pitch rate was about 5 degrees/second. The stability of the oscillation was predicted and observed to be proportional to the wing dihedral of the aircraft. For wing dihedrals of about 30 feet wing tip deflection, the pitch oscillation became dynamically unstable. The predictions of the ASWing and Matlab codes, and flight estimates are shown in Figure 9.6.

The Matlab predictions, which included time delays determined during the flight test, agreed better with the flight observations. Although both models predicted more stability than observed in flight, they clearly capture the instability. The difference between predicted and observed neutral damping is not considered significant because the differences are about the same as the uncertainty of estimating wing tip deflection from strain gauge measurements. Clearly, the light to neutrally damped oscillations observed in an event 5 to 6 minutes before the crash corroborates these predictions. Figure 9.7 and Figure 9.8 graphically captures the damping estimates represented by two of the blue circles (first encounter or event involving the unstable mode and the mishap event) in Figure 9.6.
