AEM 617

Fuel Systems

Aircraft Fuel Systems

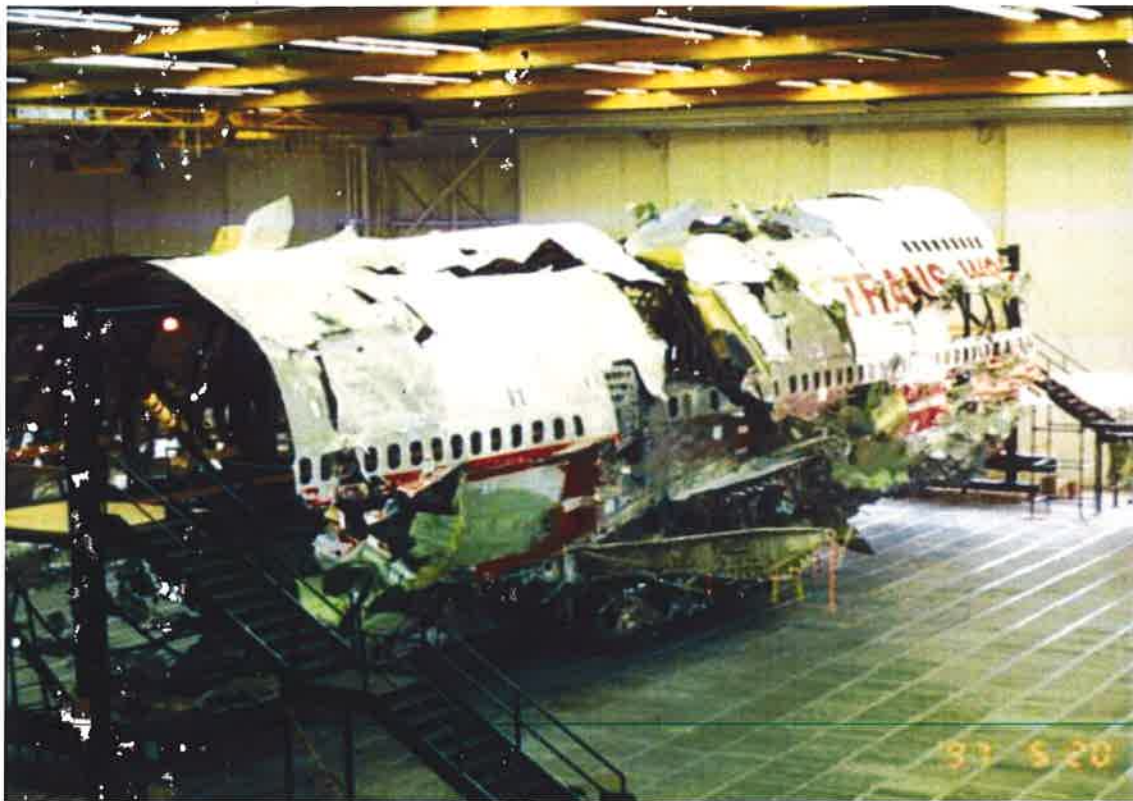
Figure 29. A photograph of the right side of the large three-dimensional reconstruction, with the support scaffolding visible.
