AEM 617 Software

Floating Point Numbers in a binary computer

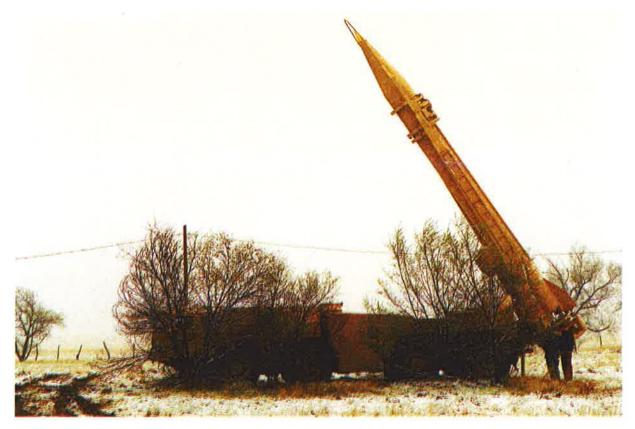
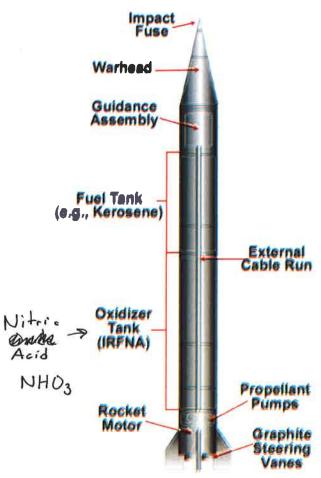
SCUD

Range ≈ 400 miles CEP ≈ 1000 m 500 ks, payload

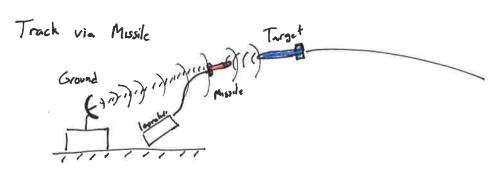
- 1) Radar signal transmitted from ground station (includes missile guidence commands)
- 2) Redar return from Meste target received by missile
- 3) Missile transmits data to ground
- 4) Ground prevident calculates missile quitame command for next transmit cycle.

Notice the huge advantage when the missile is far down range.

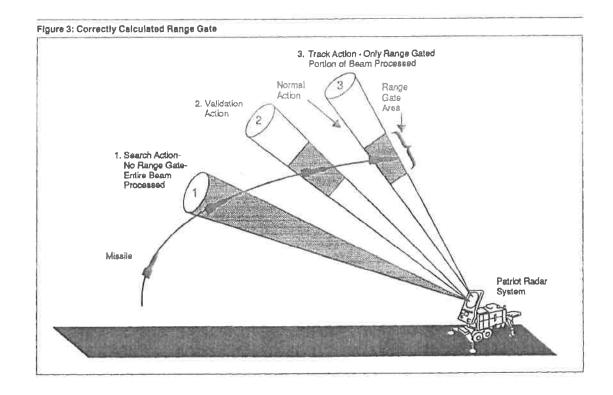
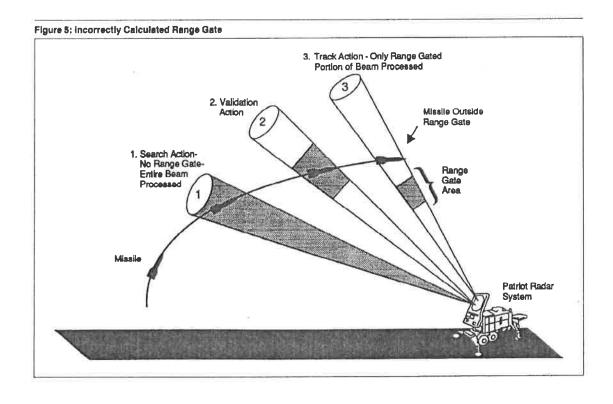
total time offset = 9.5 x 108 . 3.6 x 106 = 0.34 s

Unfortunity, a Scud travels at 4000 mph during intercept. L= at.V & 2000ft
